Western Pacific Railroad Museum MOW Department Report for 3/12/16 BOD Meeting

State of the Track

State of the Culverts

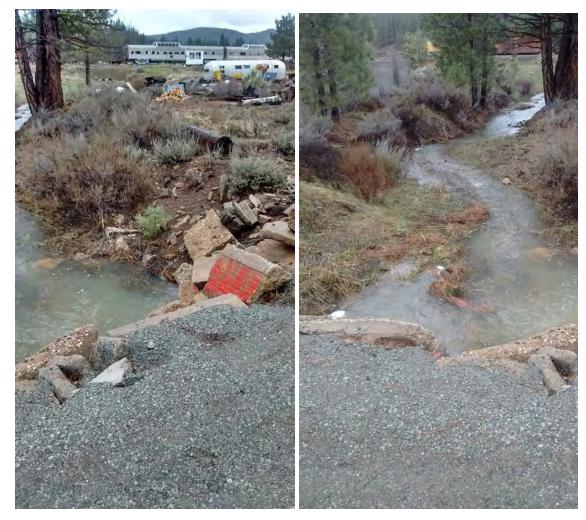
Culvert at City Road looking North

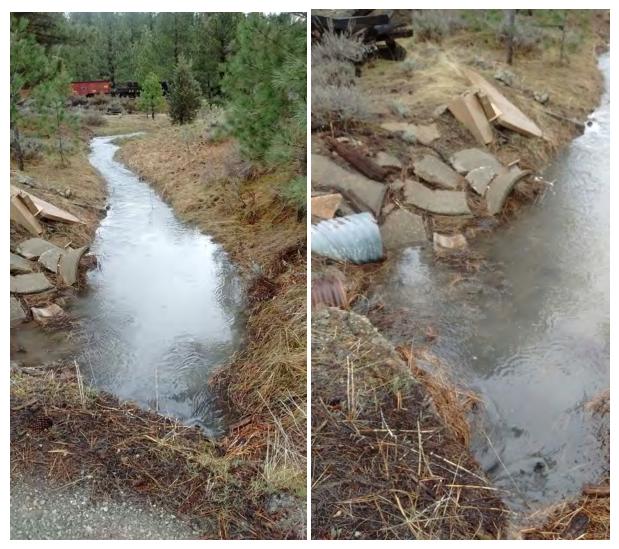
City Road Culvert Looking South

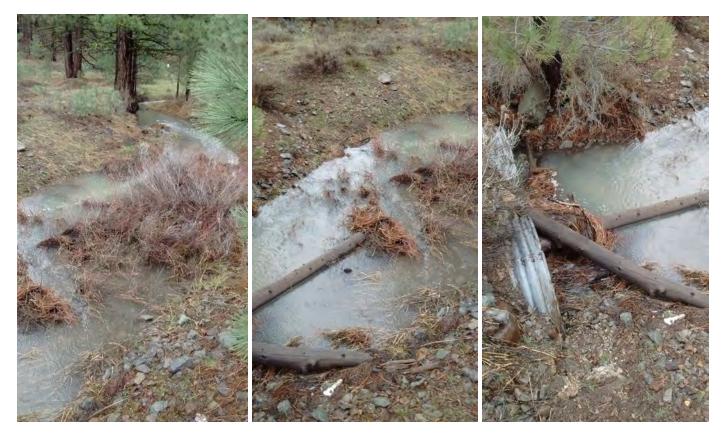
South Side Milward Culvert before Mitigation

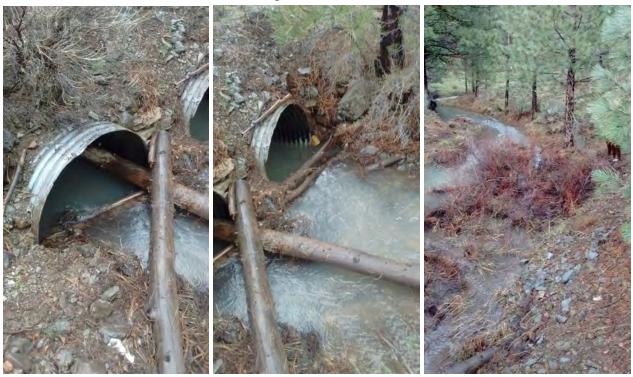
After Cleanup

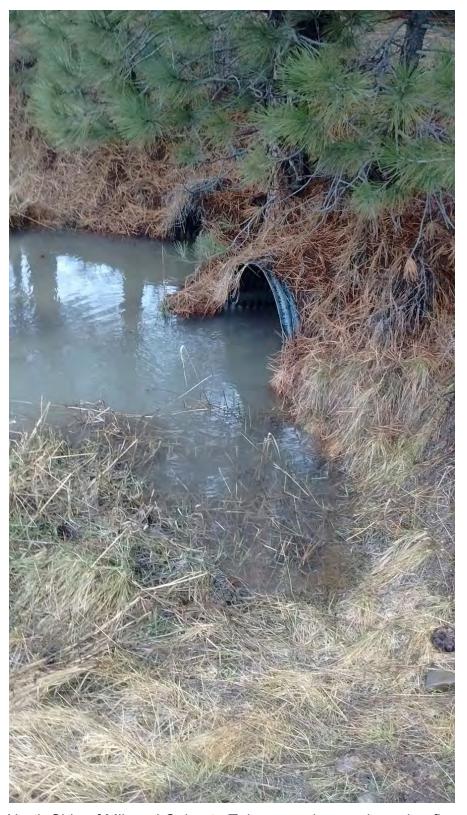
North Side of Milward Culvert. Tubes are clear and running fine.

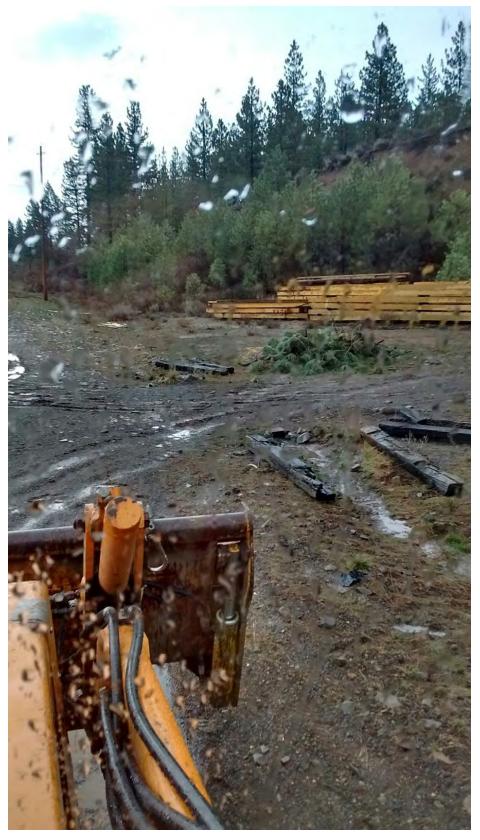
Not the best shot, but shows the ditch along foamer ally. Had to remove debris from around inlet and outlet of culvert under road. Runs well enough to drain out now rather than be a long narrow puddle.

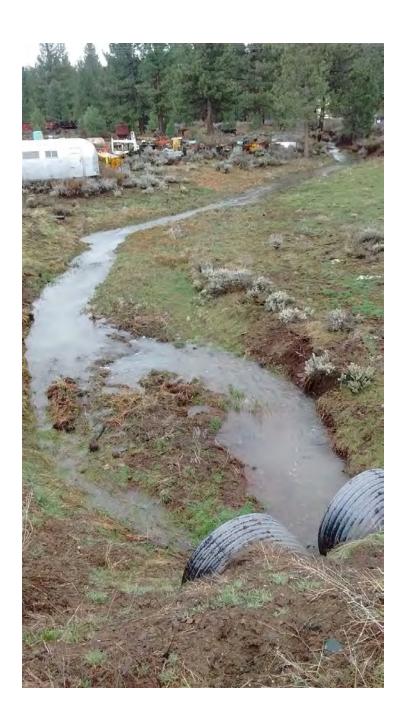
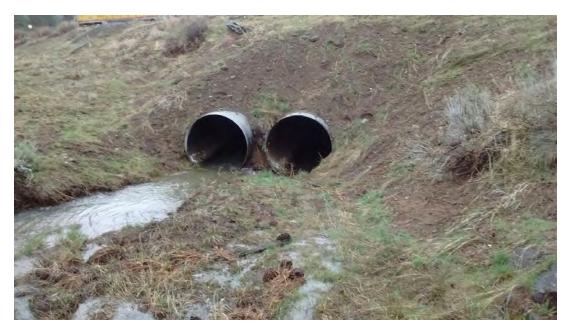
Previous photo and this one show the culvert on the north side of the balloon near the 2/3 switch. East culvert here is in the early stage of being undermined by creek.
