NATIONAL TRANSPORTATION SAFETY BOARD

RAILROAD ACCIDENT REPORT

DERAILMENT OF
WESTERN PACIFIC RAILROAD COMPANY
FREIGHT TRAIN EXTRA UP 3734 WEST
(SEALAND 6)
HAYWARD, CALIFORNIA
APRIL 9, 1980

NTSB-RAR-80-10

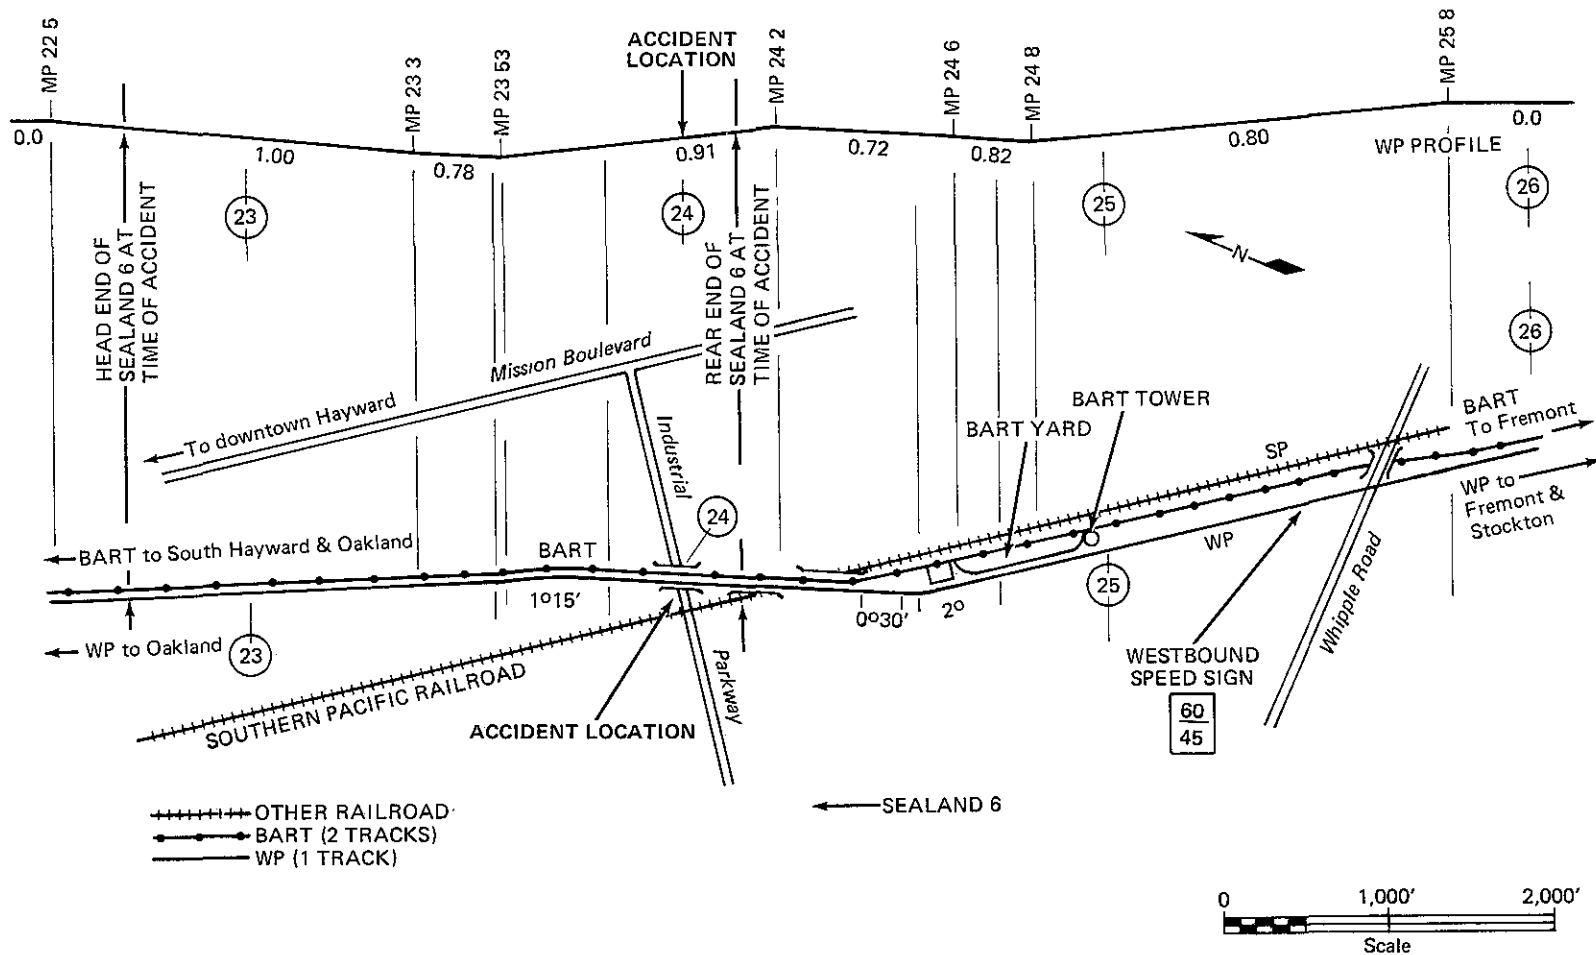
Figure 1.--Diagram and profile of accident location and approach from Milepost 25.8.

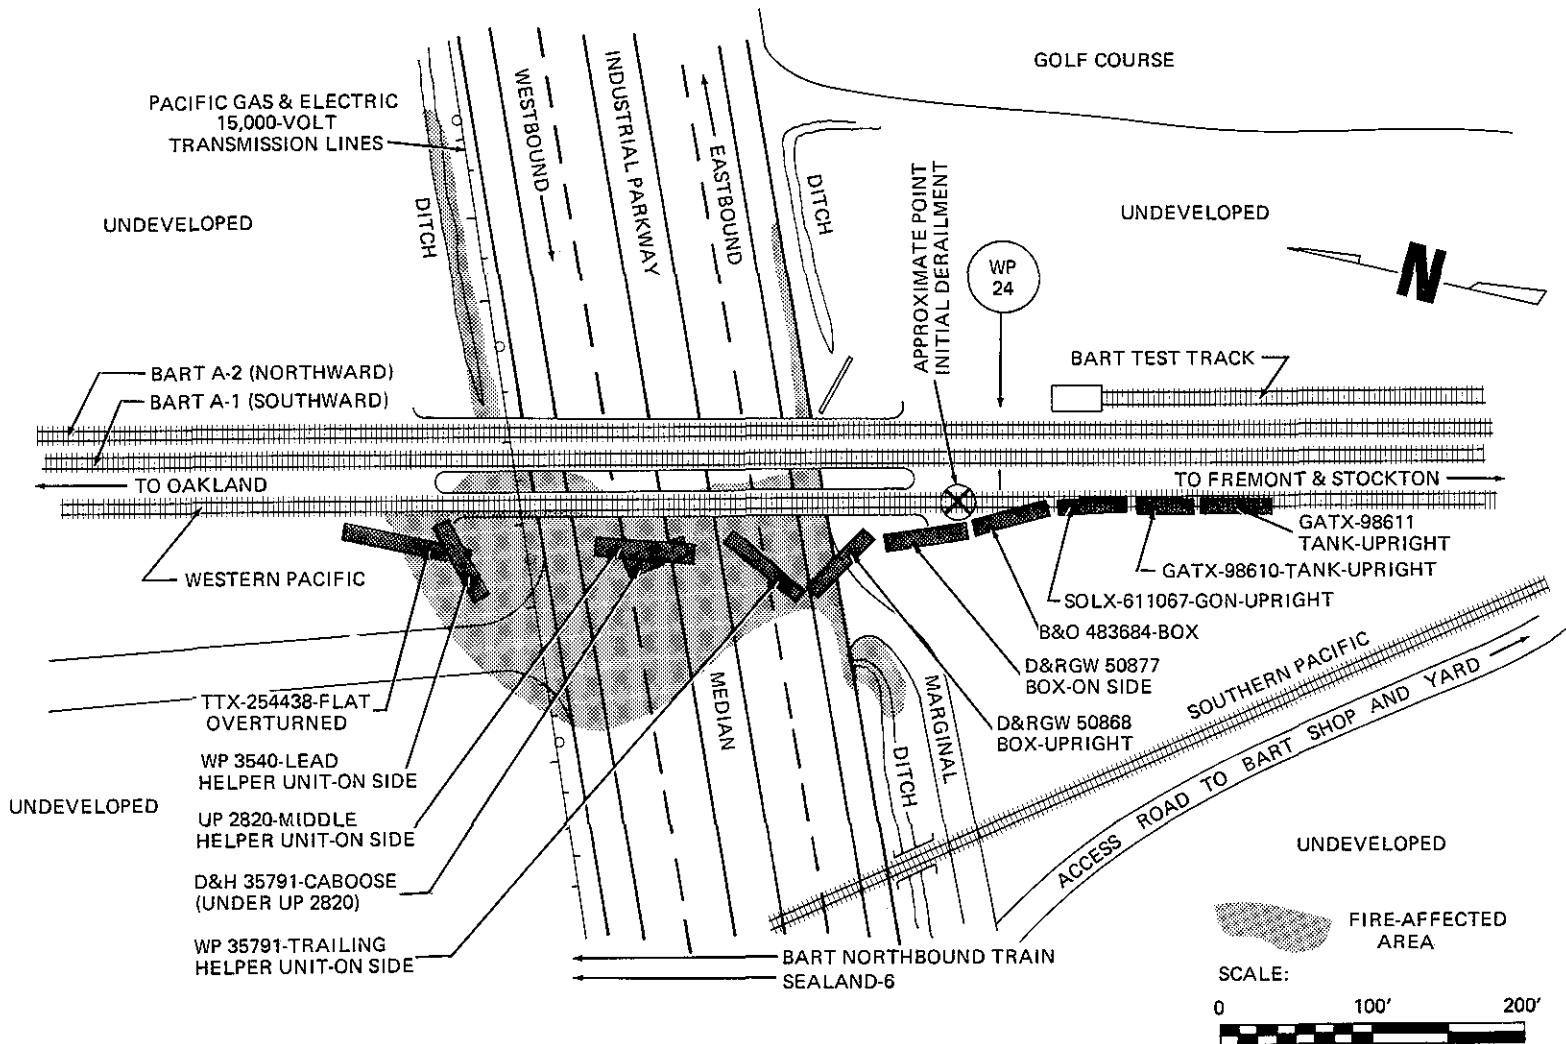
eastbound traffic lane. (See figure 2.) The fuel tanks of all three units were ruptured in the derailment and escaping fuel was ignited immediately by the arcing of 15,000-volt Pacific Gas and Electric (PG & E) powerlines that had been severed in the derailment. (See figure 2.)

Figure 2.--Plan view of accident site and wreckage distribution.

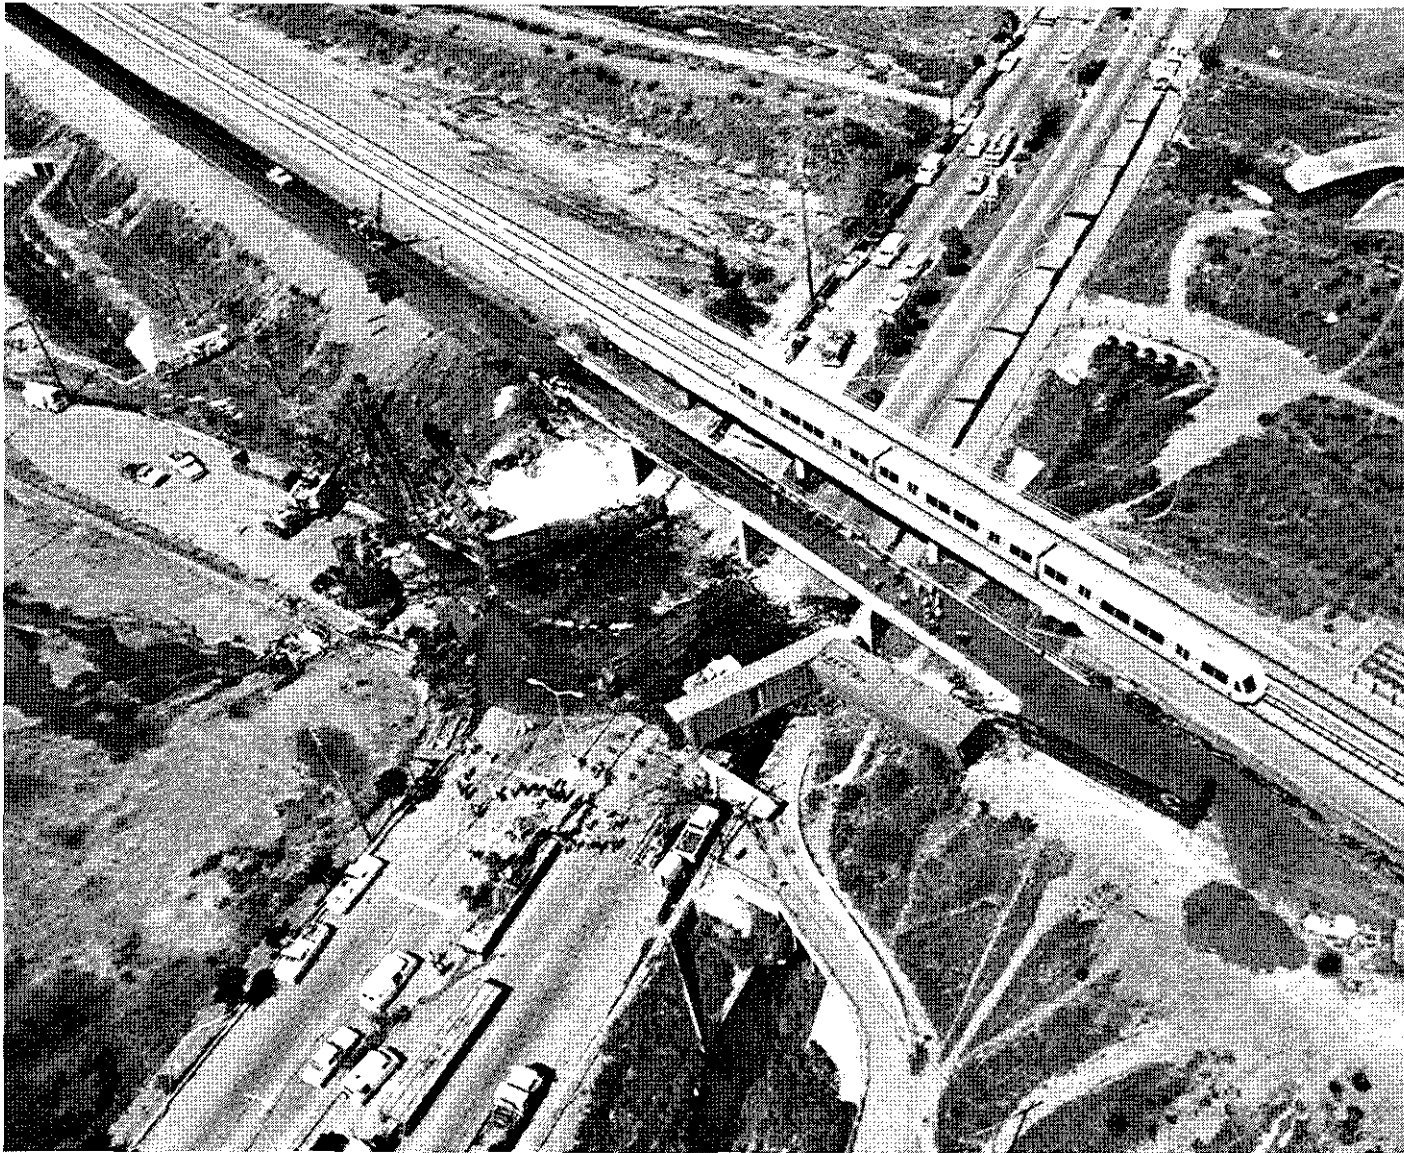
The 230-foot overpass over Industrial Parkway is a prestressed concrete ballast deck bridge with concrete backwalls and a center pier. The track is about 30 feet above the highway and approaches the bridge on long fills. The track was maintained according to FRA Class 4 standards and was in good condition. The rail was jointed 119-pound in 78-foot lengths laid in double-shoulder tie plates on 7-inch by 9-inch by 9-foot treated crossties. There were no guard rails. The right-of-way is shared with the double-track line of the Bay Area Rapid Transit District (BART) between Fremont and Oakland. At Industrial Parkway, the WP and BART tracks are about 20 feet apart, with each railway having its own bridge. (See figure 3.)

Figure 3.--Aerial view of the accident location viewed to the northeast.
The BART train is southbound en route from Oakland to Fremont.

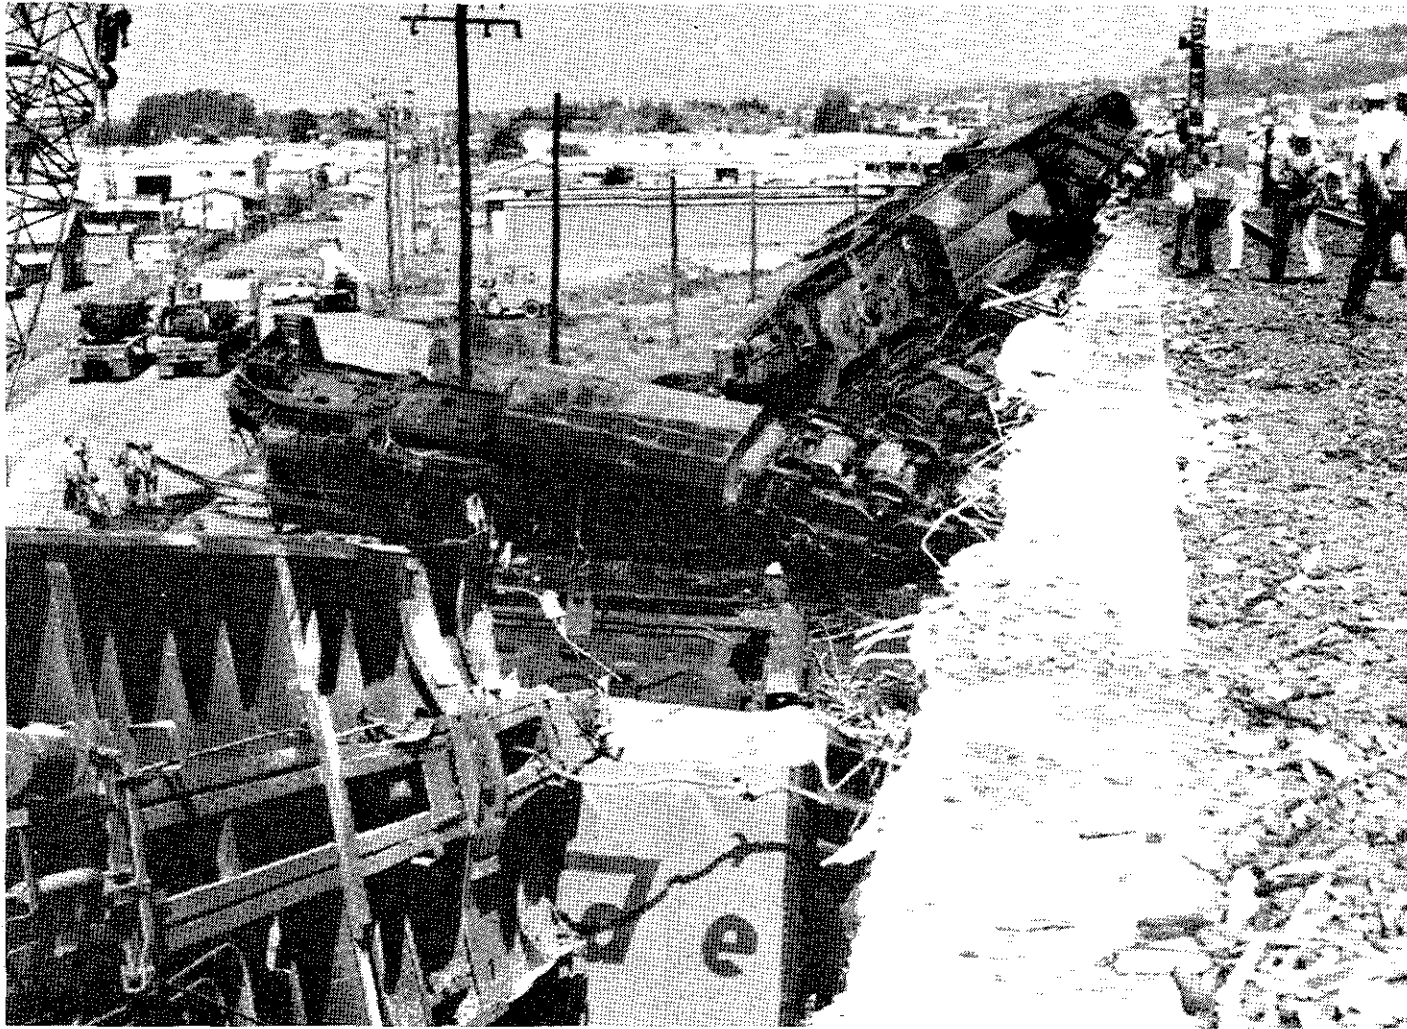
Figure 4.--Derailed locomotive units and cars viewed from Bridge 23.93.
The lead RBW-9 unit is at the far end of the bridge as it came to rest after derailing.

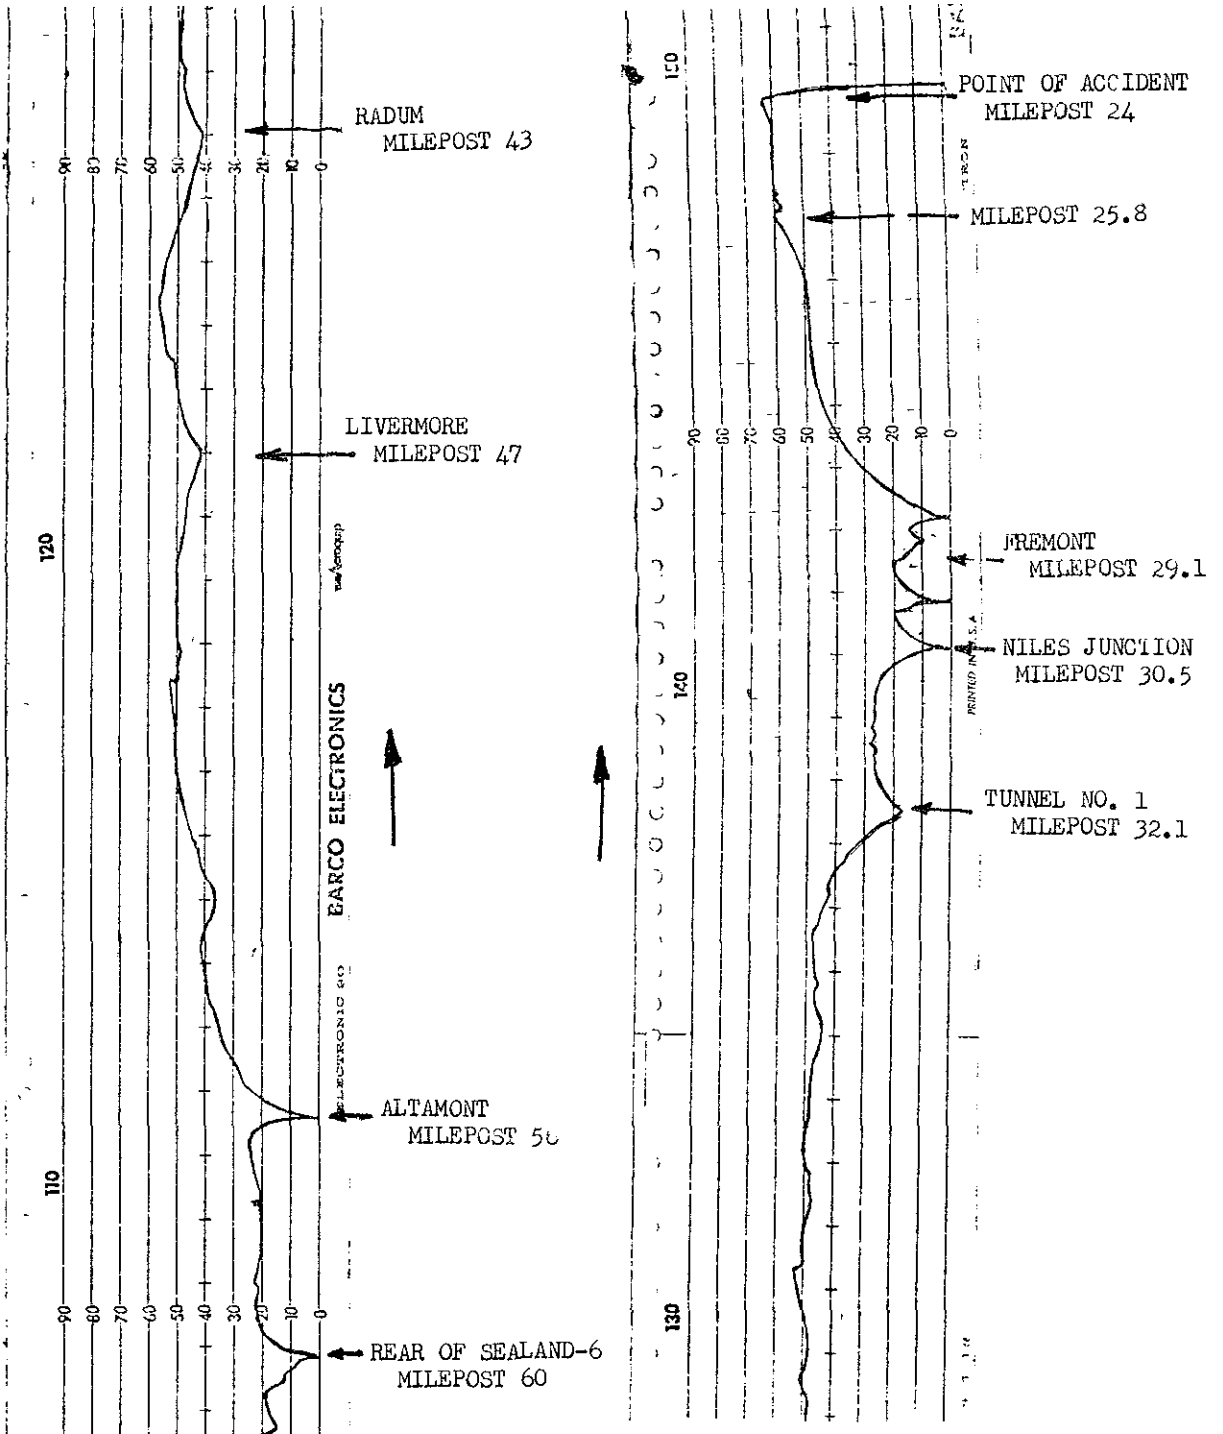
APPENDIX E

Although the trailing helper unit was destroyed by fire, the speed recorder on this unit yielded a legible and undamaged tape. The recorder was calibrated and found to be accurate within 0.1 mph.

SPEED RECORDER TAPE REMOVED FROM THE LOCOMOTIVE OF RBW-9
