No. 118-5 4-22-58 North Fork Bridge looking upstream. Beginning at north side of low level crossing PG&E sandbar in center to be used as Contractor's yard.

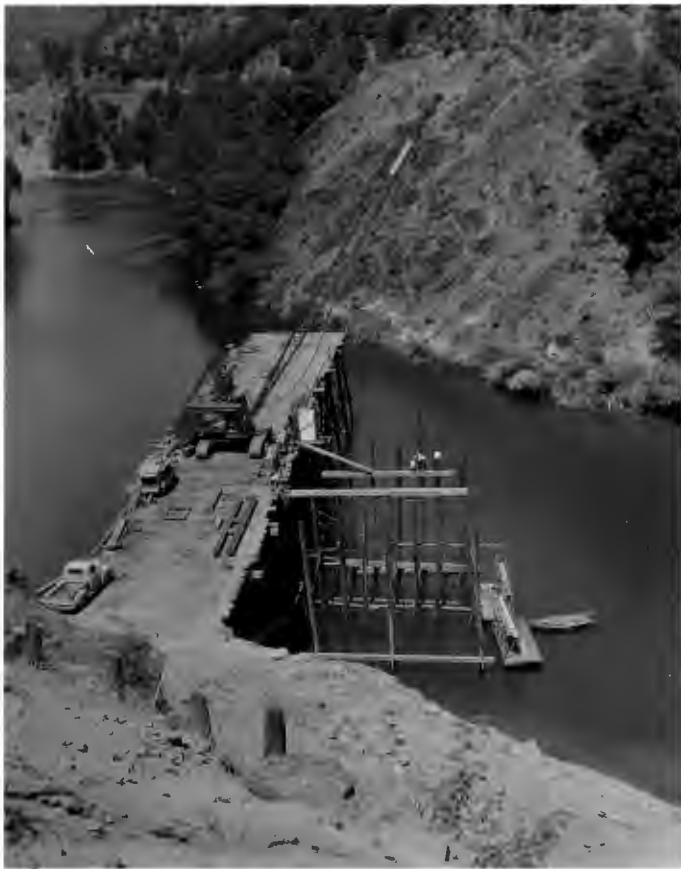
No. 146-5 7-29-58  
North Fork Bridge looking  
upstream at Contractor's work  
trestle. Pier No. 2 in fore-  
ground. Pier No. 3 across  
the river.

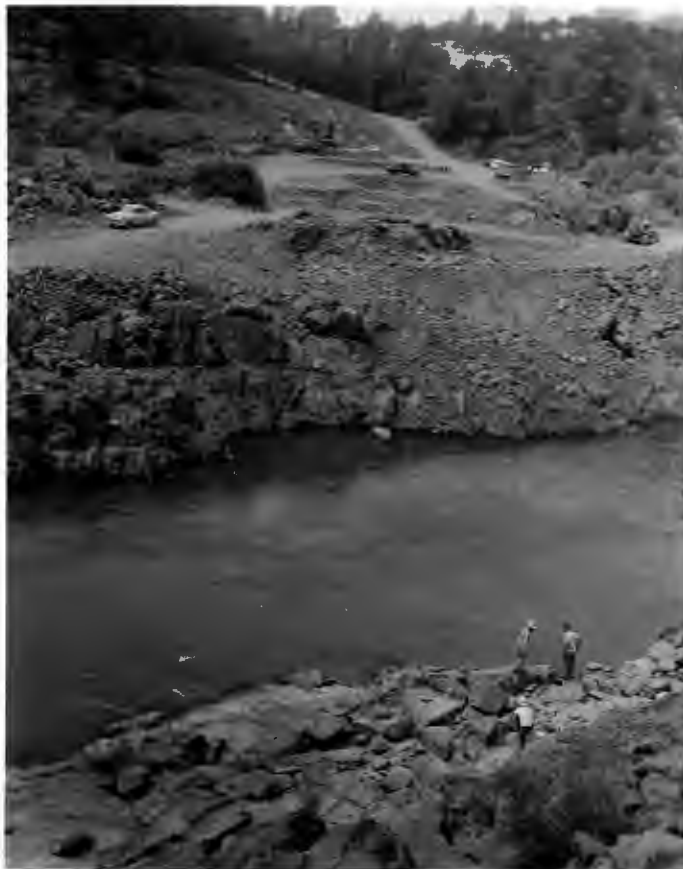
No. 147-1 7-29-58  
Feather River Bridge. Three men  
standing at location Pier No. 3.  
Pier No. 4 directly across stream.  
Pier No. 10 located at top center  
looking ahead on line.

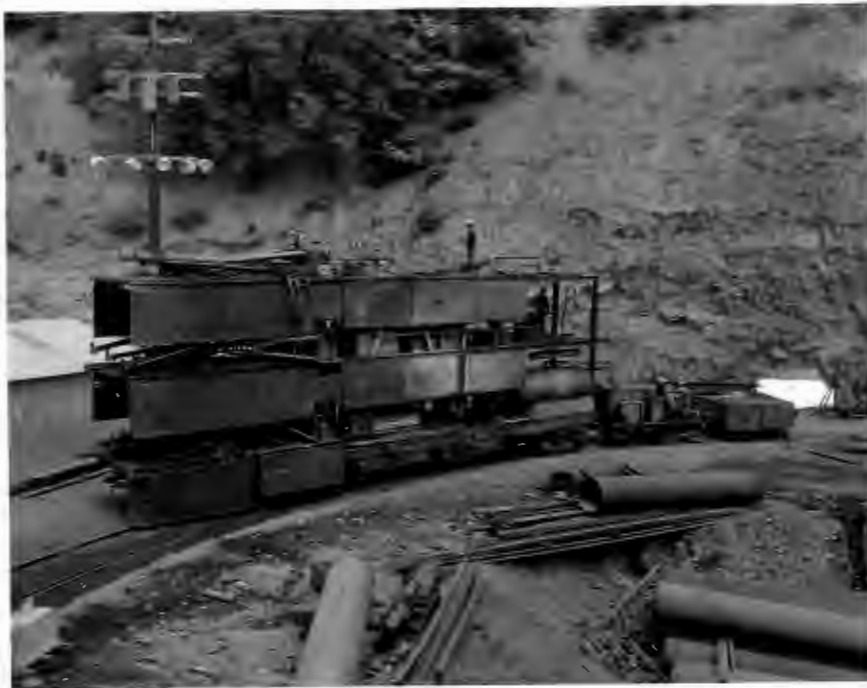
No. 149-9 7-29-58 Tunnels 4 and 5 (W.P.R.R. 7 and 8). View of drilling Jumbo being loaded with lagging prior to run into tunnel.

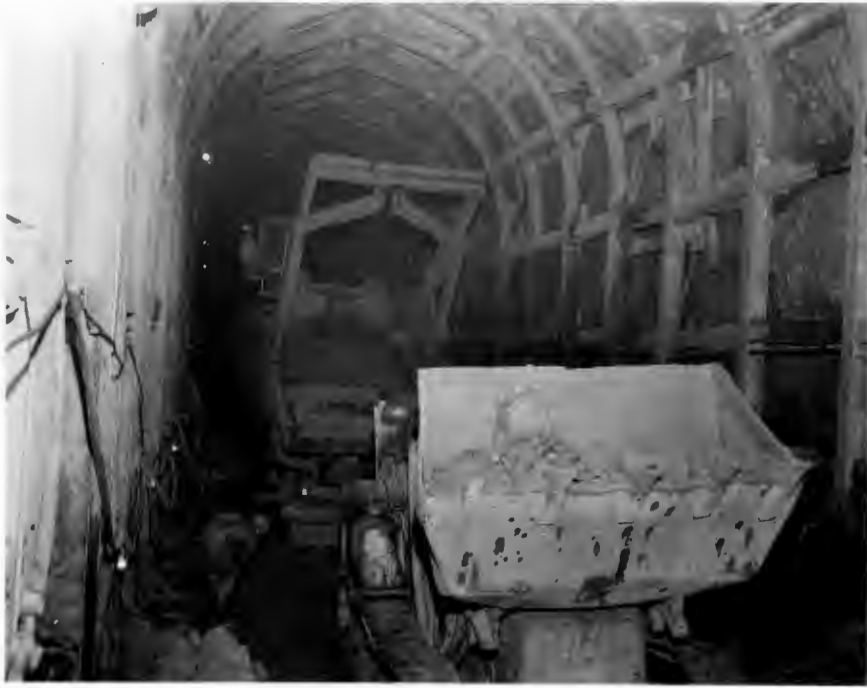
No. 154-1 8-18-58 Tunnels Nos. 4 and 5 (N.P.R.R. Nos. 7 and 8).  
Loading muck train after blasting. Note rock being moved to forward part of train.

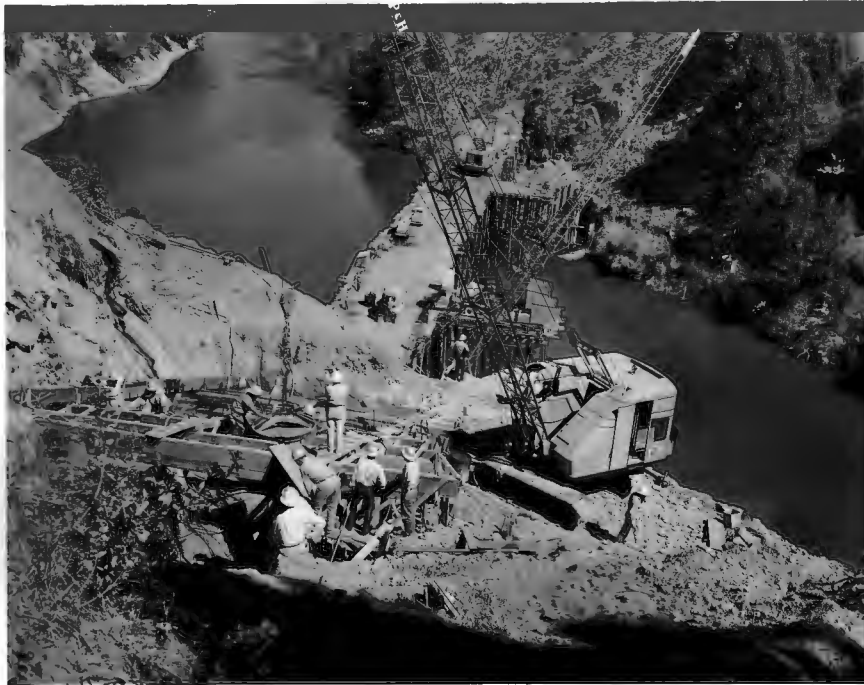
No. 166-1 9-19-58 North Fork Bridge. Placing concrete for footing  
Pier No. 1 - view ahead on line shows Contractor's work trestle near  
completion.

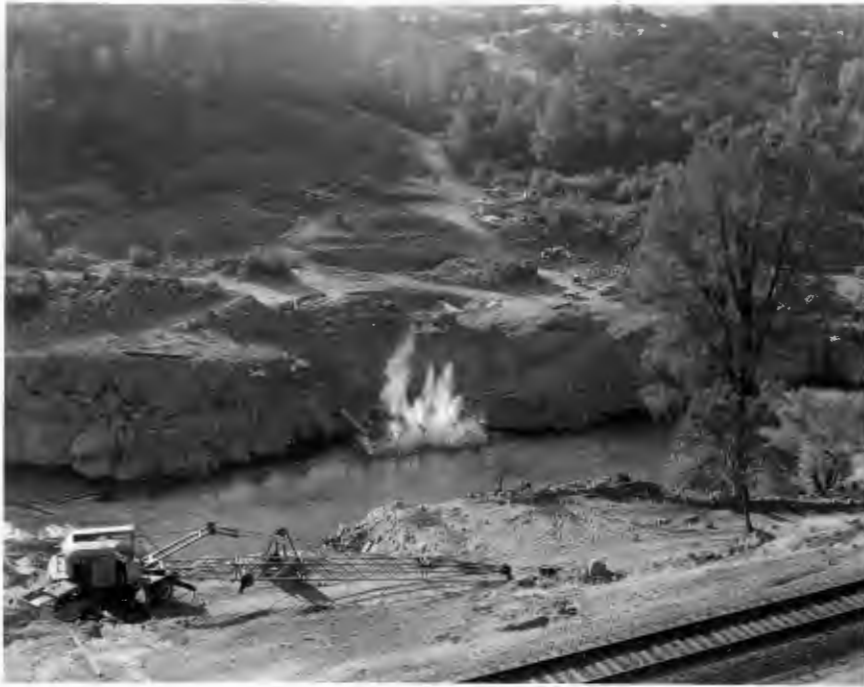
No. 168-1 9-19-58 Feather River Bridge. View of underwater blast at Pier No. 4 looking ahead on line at succeeding pier locations.

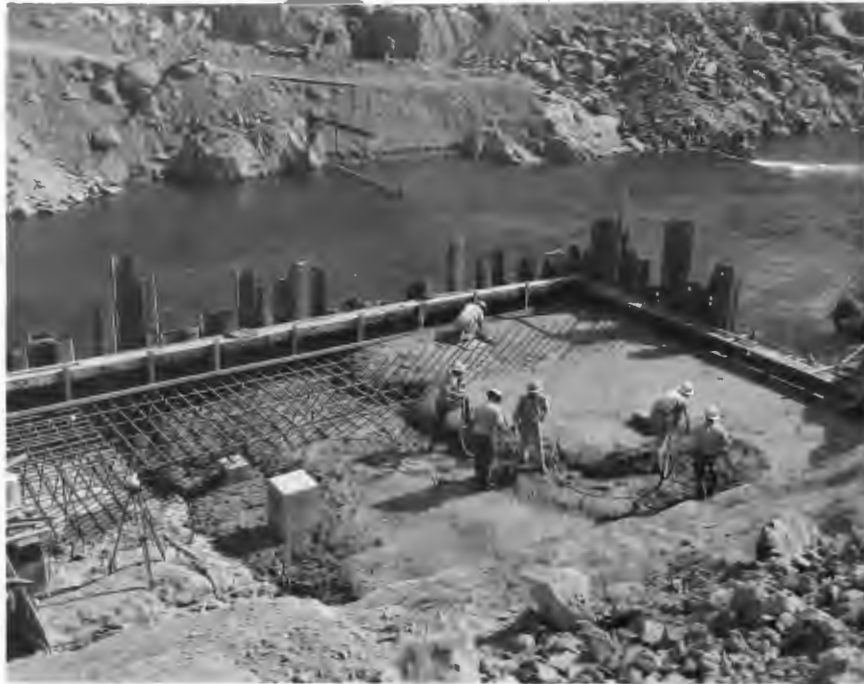
No. 189-3 10-16-58 Feather River Bridge. View back on line at concrete placing operation at Pier No. 4.

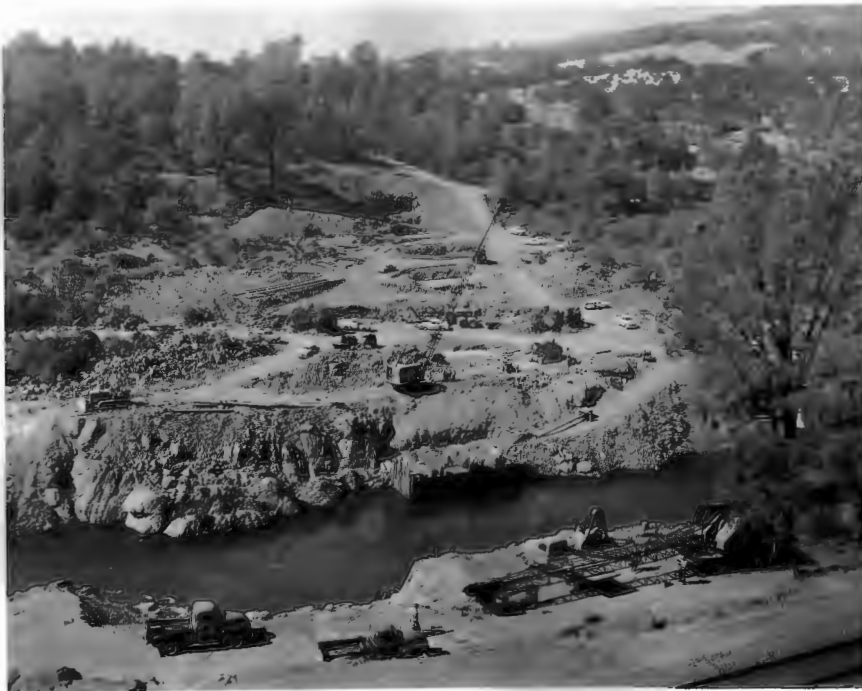
No. 189-4 10-16-58 Feather River Bridge. View ahead on line from Pier No. 2. Crane placing concrete at Pier No. 4.

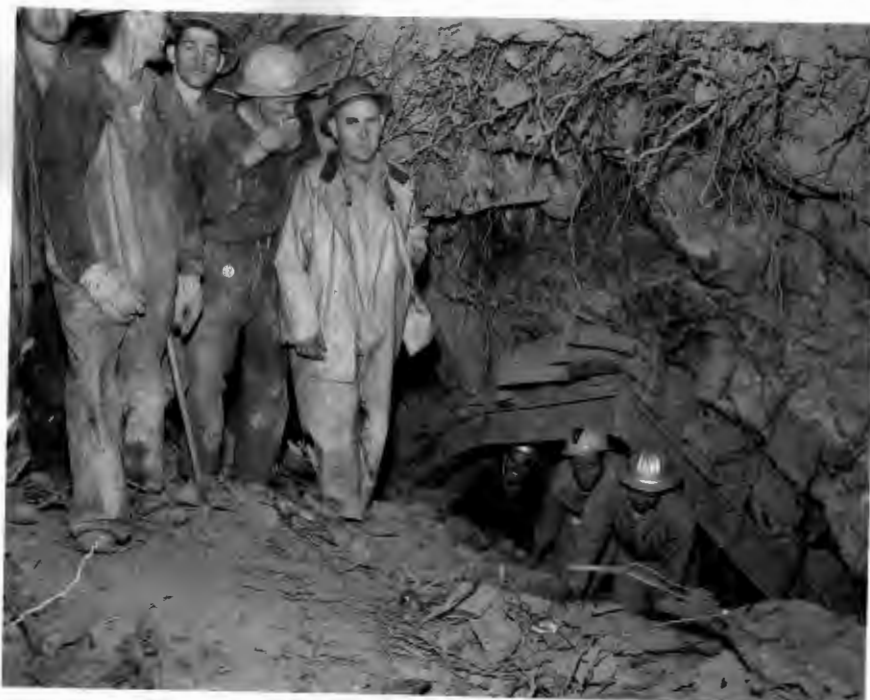
No. 188-3 10-25-58 Tunnel No. 4 (W.P.R.R. No. 7). Hole through at Portal 4 West, 1:44 a.m., October 25, 1958. Ten months elapsed time.

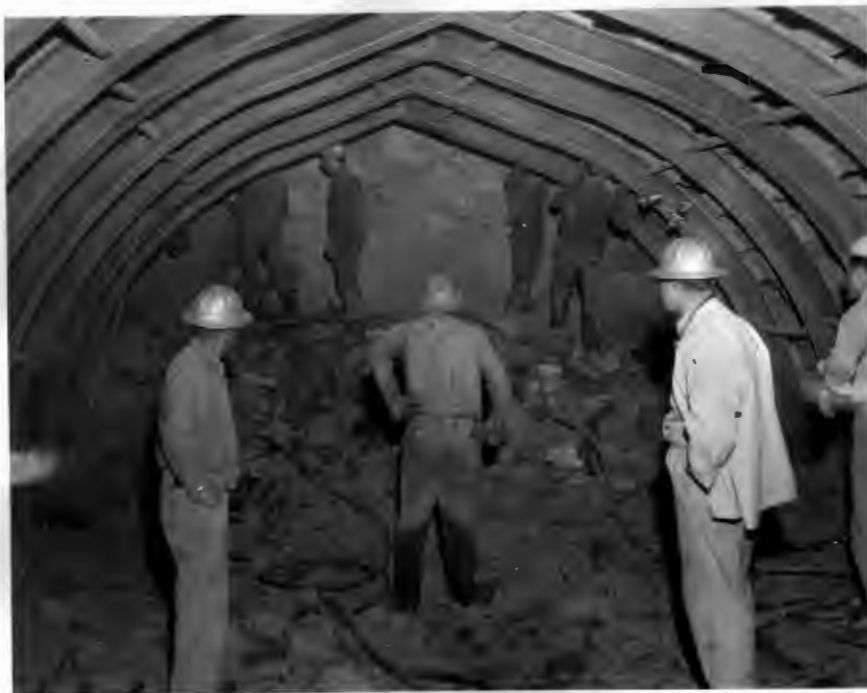
No. 188-5 10-25-58 Tunnel No. 4 (W.P.R.R. No. 7). Placing final lagging prior to holing out of Portal 4W.

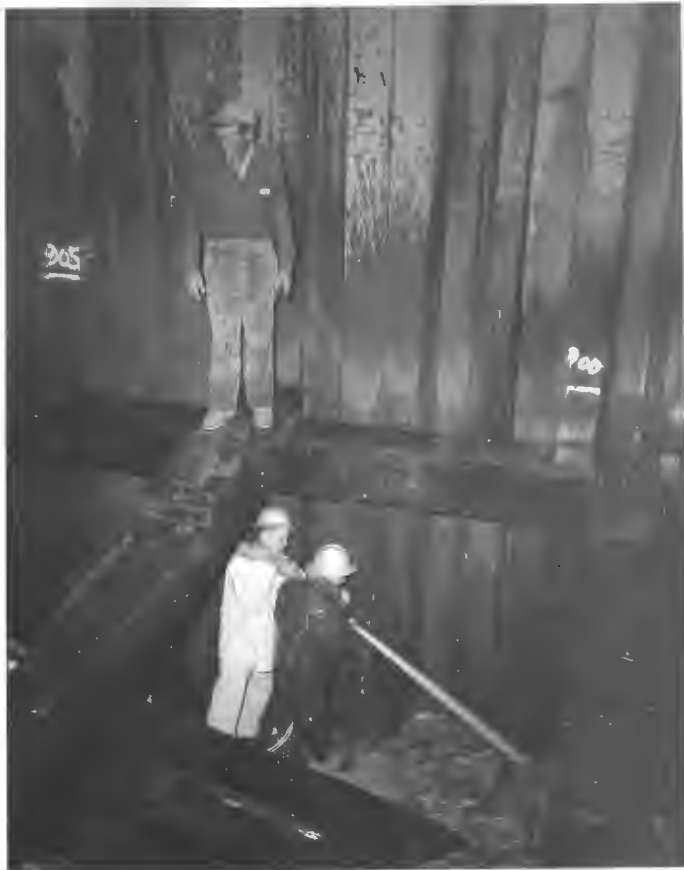
No. 191-1 10-16-58  
North Fork Bridge. Washing  
down bedrock before placing  
reinforcing steel at Pier No. 3.

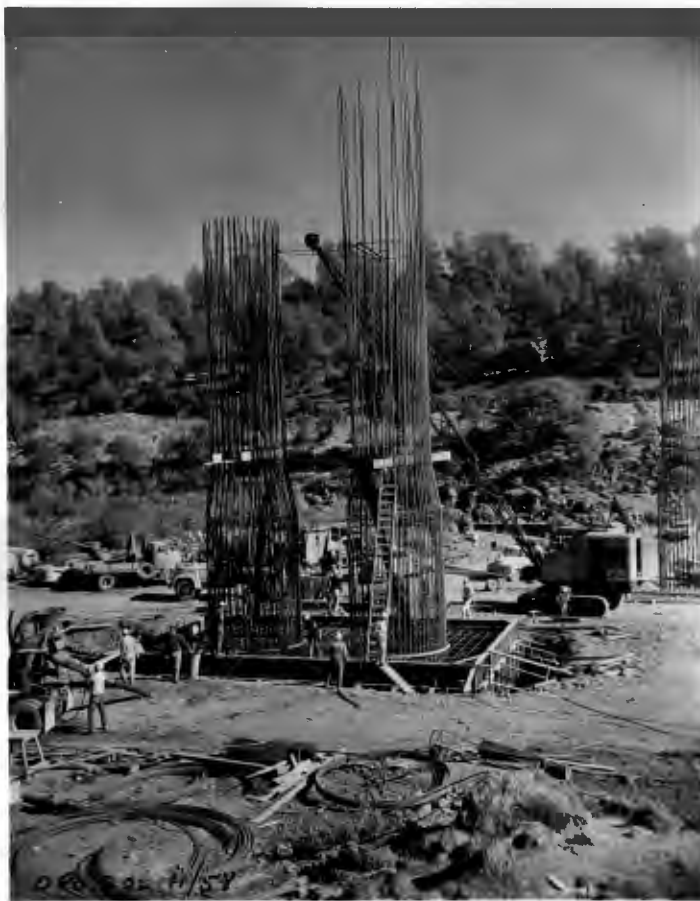
No. 202 11-7-58  
Feather River Bridge. View  
showing men and equipment  
at work placing concrete on  
Pier No. 8.

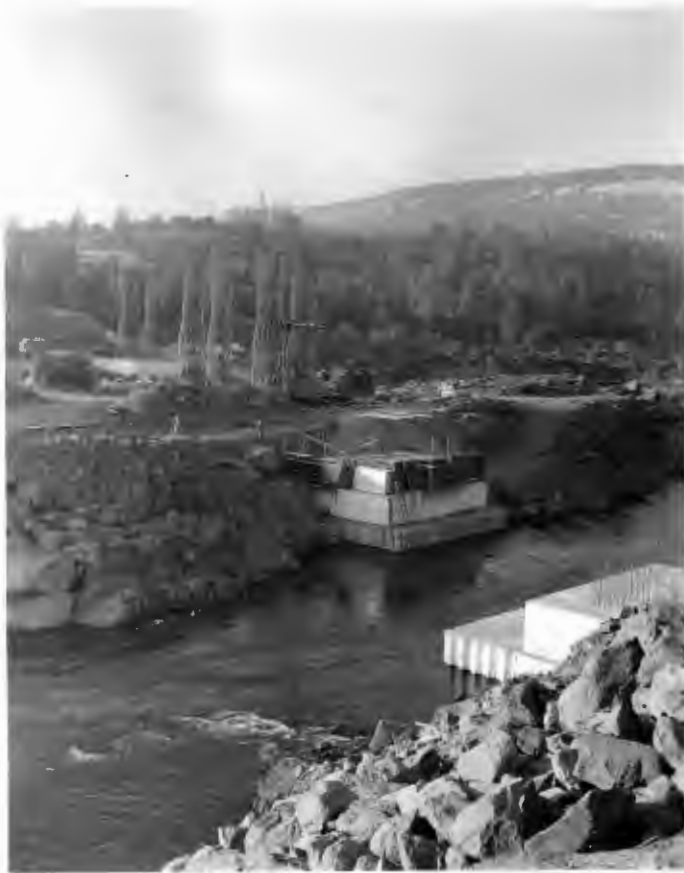
No. 235-2 12-14-58  
Feather River Bridge.  
Overall view looking  
ahead on line. Steel  
workers making final  
ties on reinforcing steel,  
Pier No. 6.

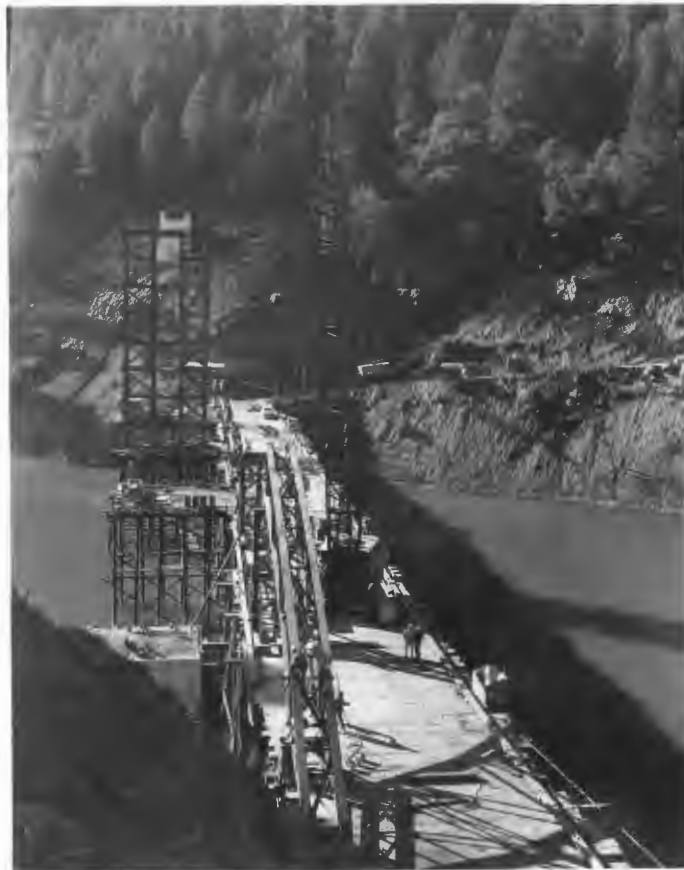
No. 239-1 12-15-58  
North Fork Bridge. View  
back on line shows center  
support tower partially  
assembled half main false  
work section.

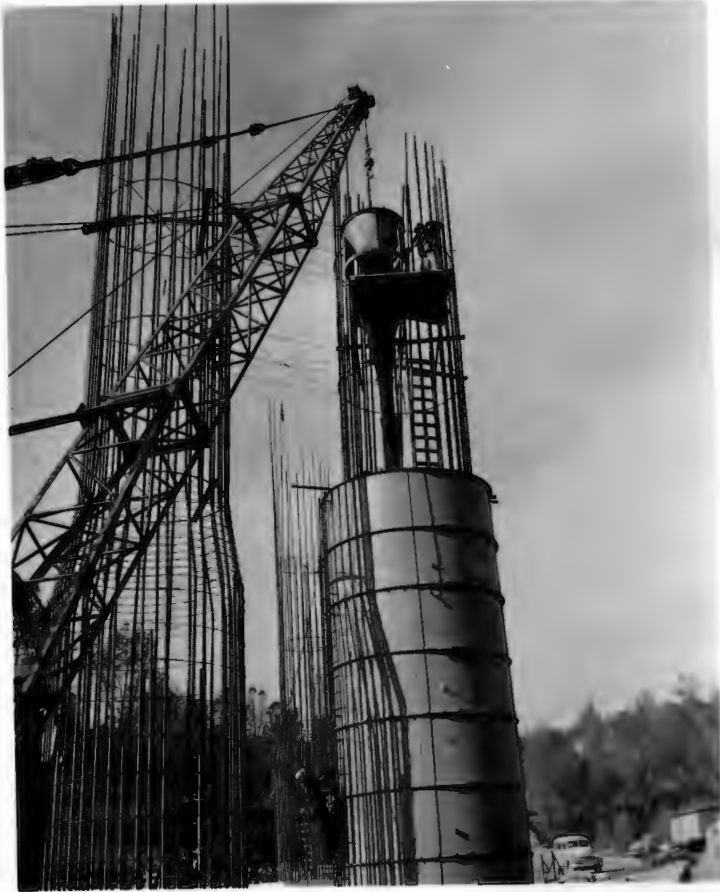
No. 227 12-19-58  
Feather River Bridge.  
Close-up of concrete  
placing operation at  
Pier No. 6, using  
platform and tremie  
tube.

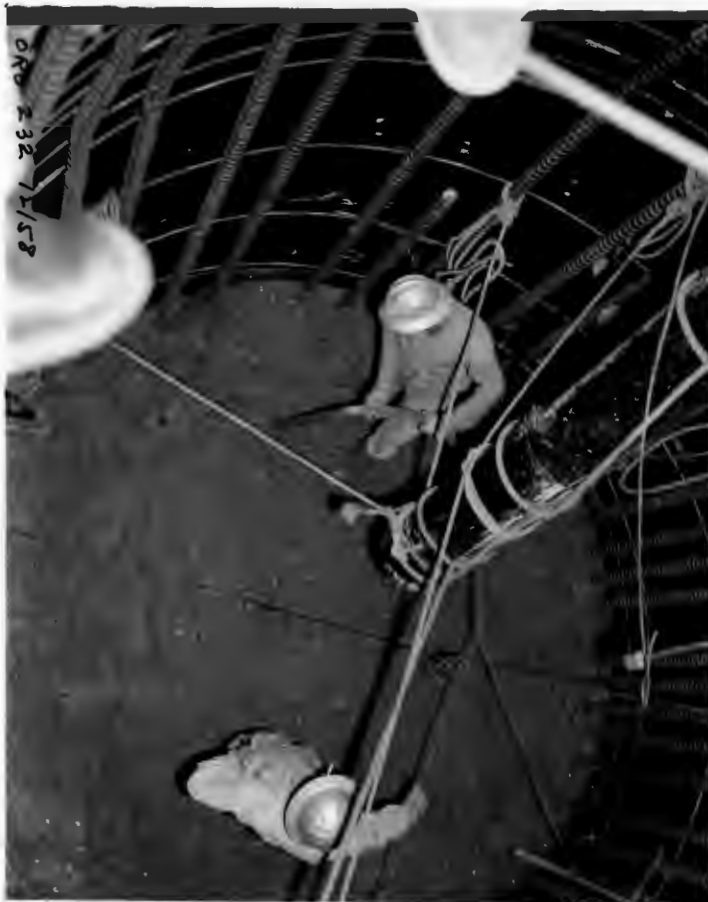
No. 232 12-19-58  
Feather River Bridge.  
Vibrating concrete in  
Pier No. 6.

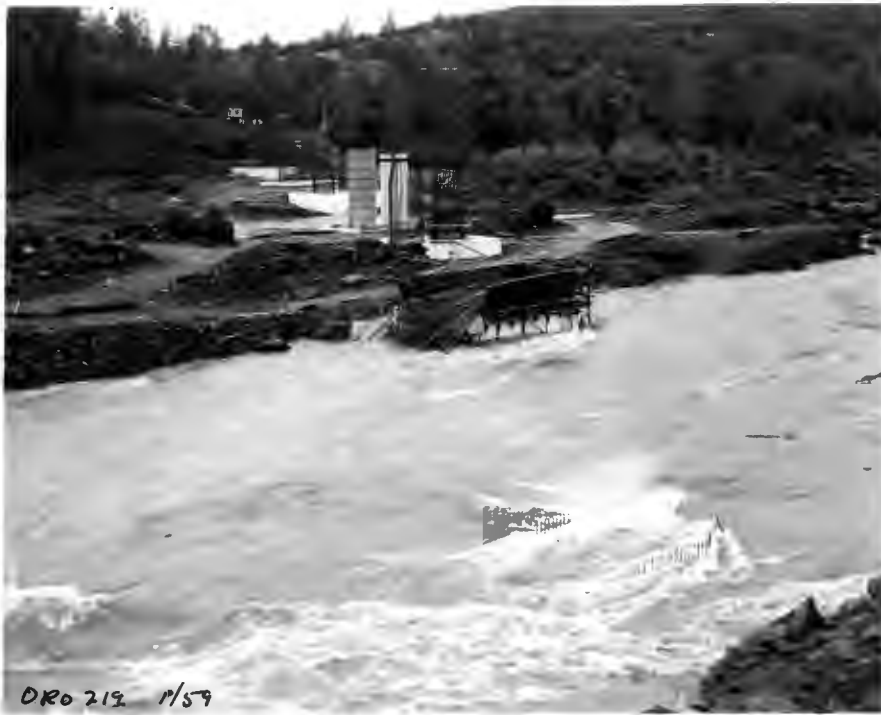
**No. 219 1-12-59 Feather River Bridge. Looking ahead on line. Note reinforcing steel of Pier No. 3 in foreground. Collapsed reinforcing steel on Pier No. 4 across river.**

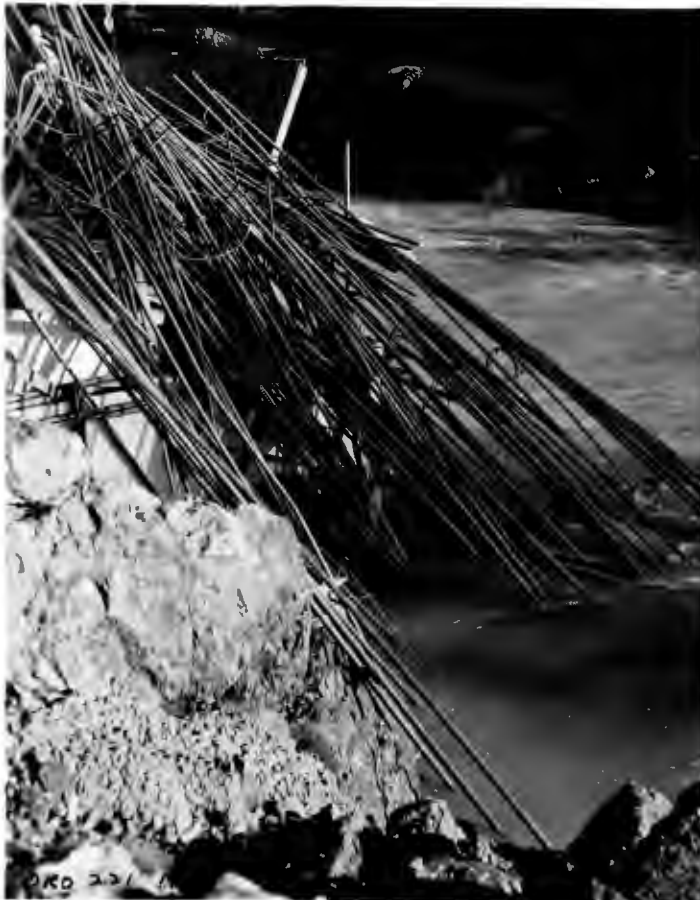
**No. 221 1-13-59 Feather River Bridge Pier No. 4. Close-up of No. 18 bar steel lying in river.**

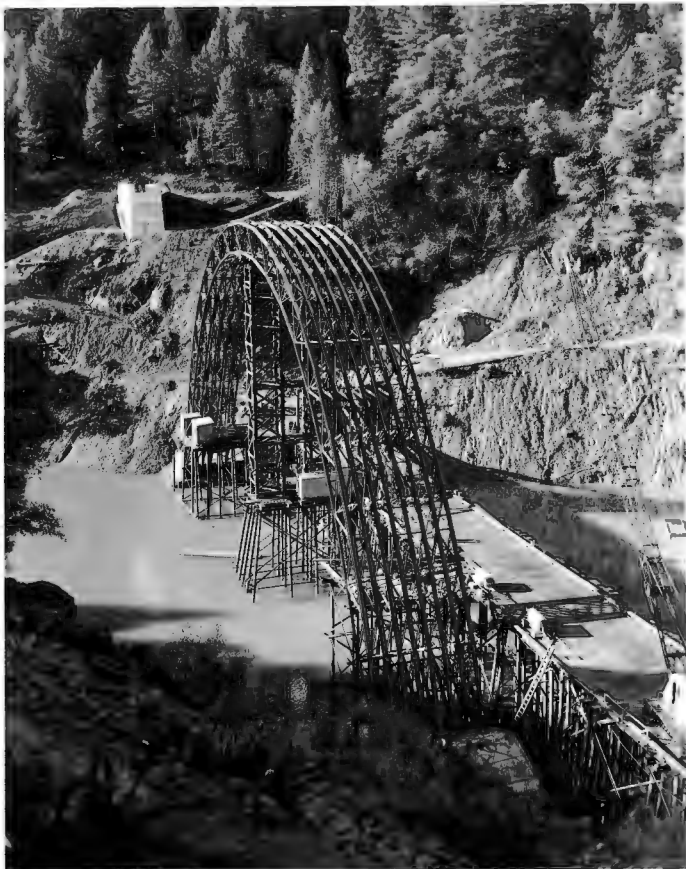
No. 259-4 1-30-59  
North Fork Bridge.  
Looking back on line at  
main falsework arch between  
Piers Nos. 2 and 3, Pier  
No. 1 at upper left.

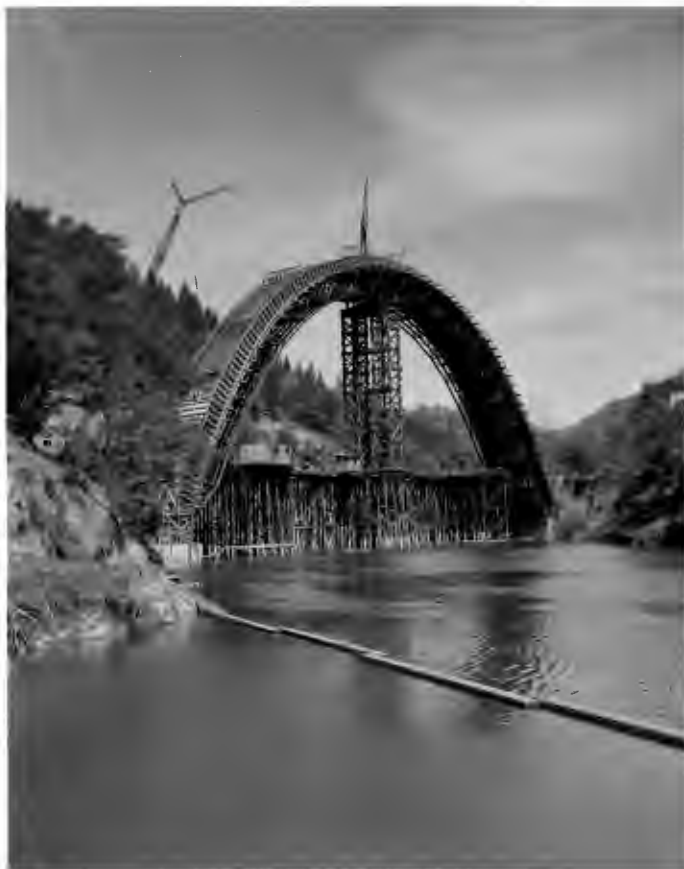
No. 311-2  
North Fork Bridge, looking  
upstream at main falsework  
arch between Piers Nos. 2  
and 3.

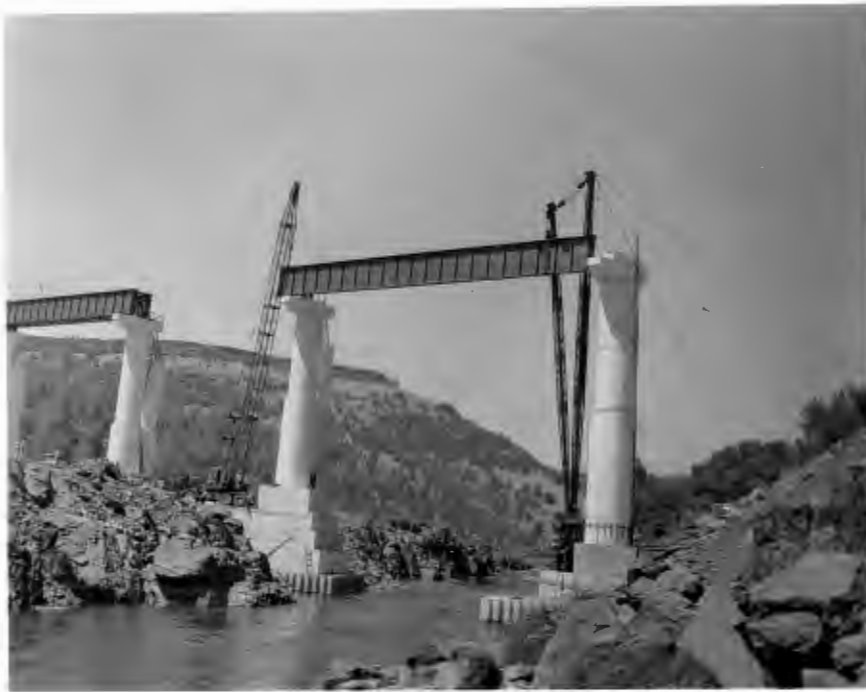
No. 421-3, Feather River Bridge. View of girder being positioned on pier caps.

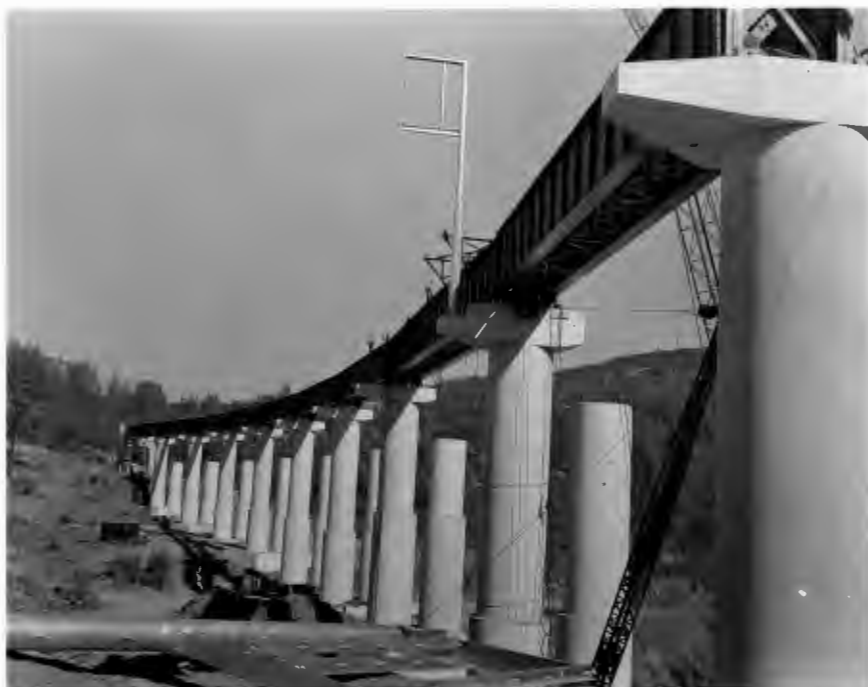
No. 426-7 7-27-59 Feather River Bridge. View of underside of in-place girders during erection.

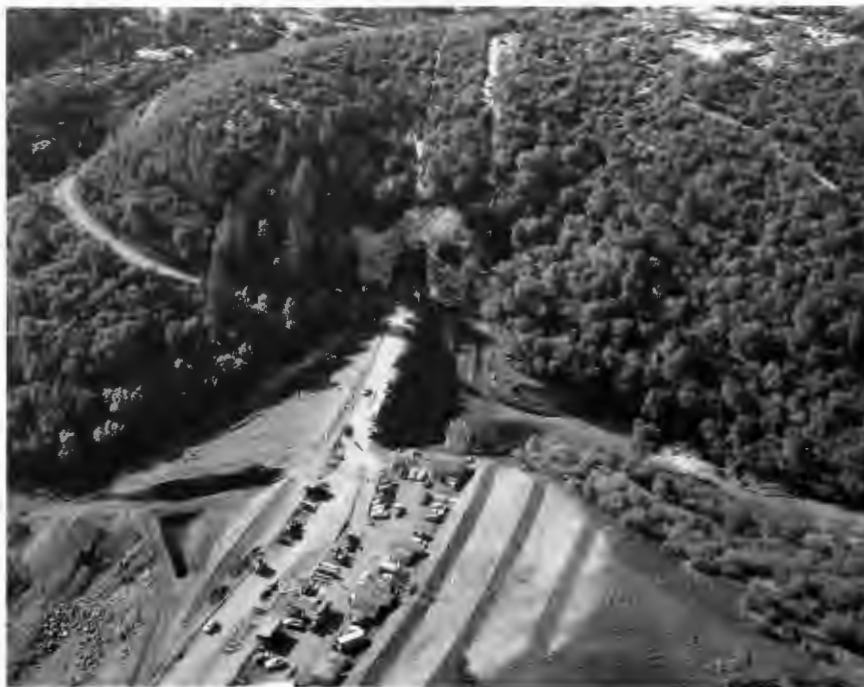
No. 562-4 1-15-60 Tunnels Nos. 2 and 3 (W.P.R.R. Nos. 5 and 6).  
Portal 2E interceptor ditch over Portal. Cut slopes and fill over  
138-inch CIMP and 150-inch CIMP. Inlet to 138-inch CIMP at  
Station 1002+08.

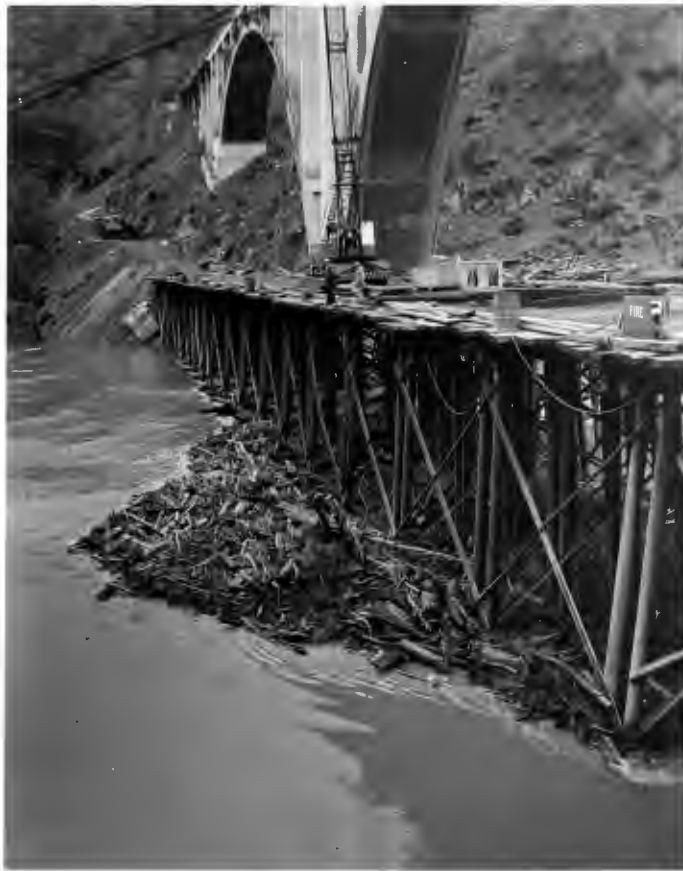
No. 582-1 2-9-60  
North Fork Bridge. Debris  
piling up at the work trestle  
during high water.

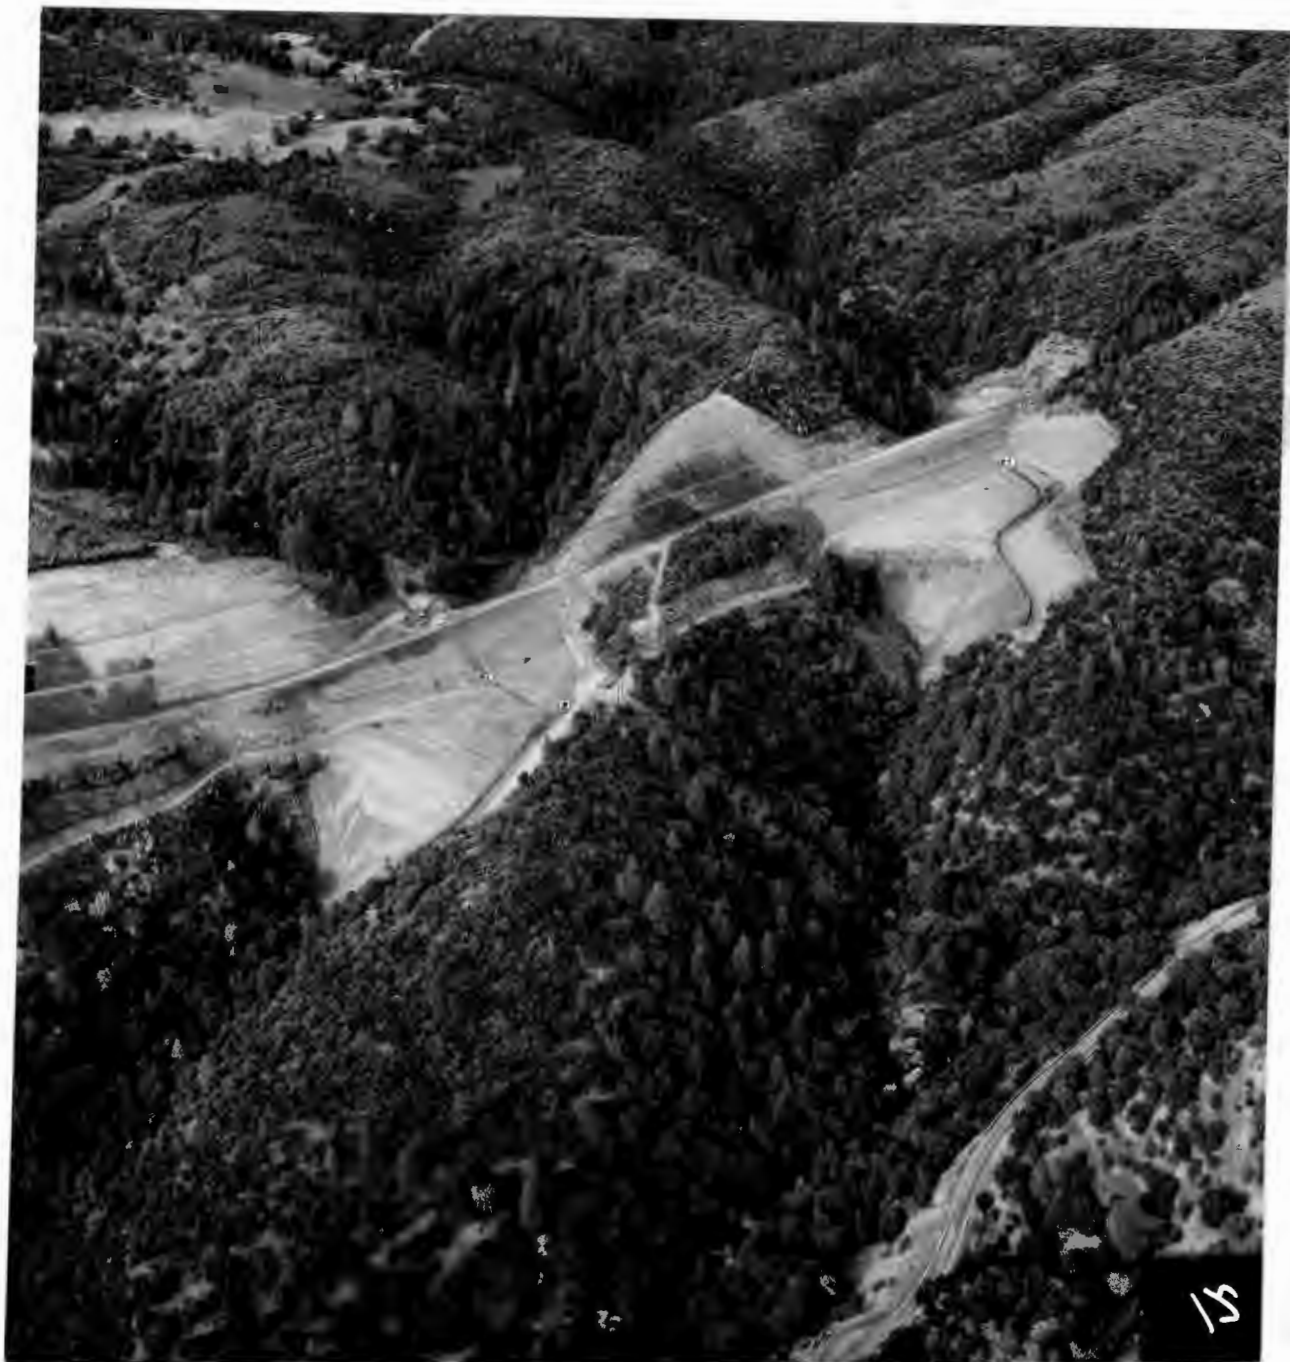
No. 853-12 11-28-60 Tunnels Nos. 2 and 3 (W.P.R.R. Tunnels Nos. 5 and 6).  
Aerial view of waste area right of Station 1065- and Station 1076<sup>+</sup>. Grizzly  
Creek is passed through twin 126-inch culvert at right center.

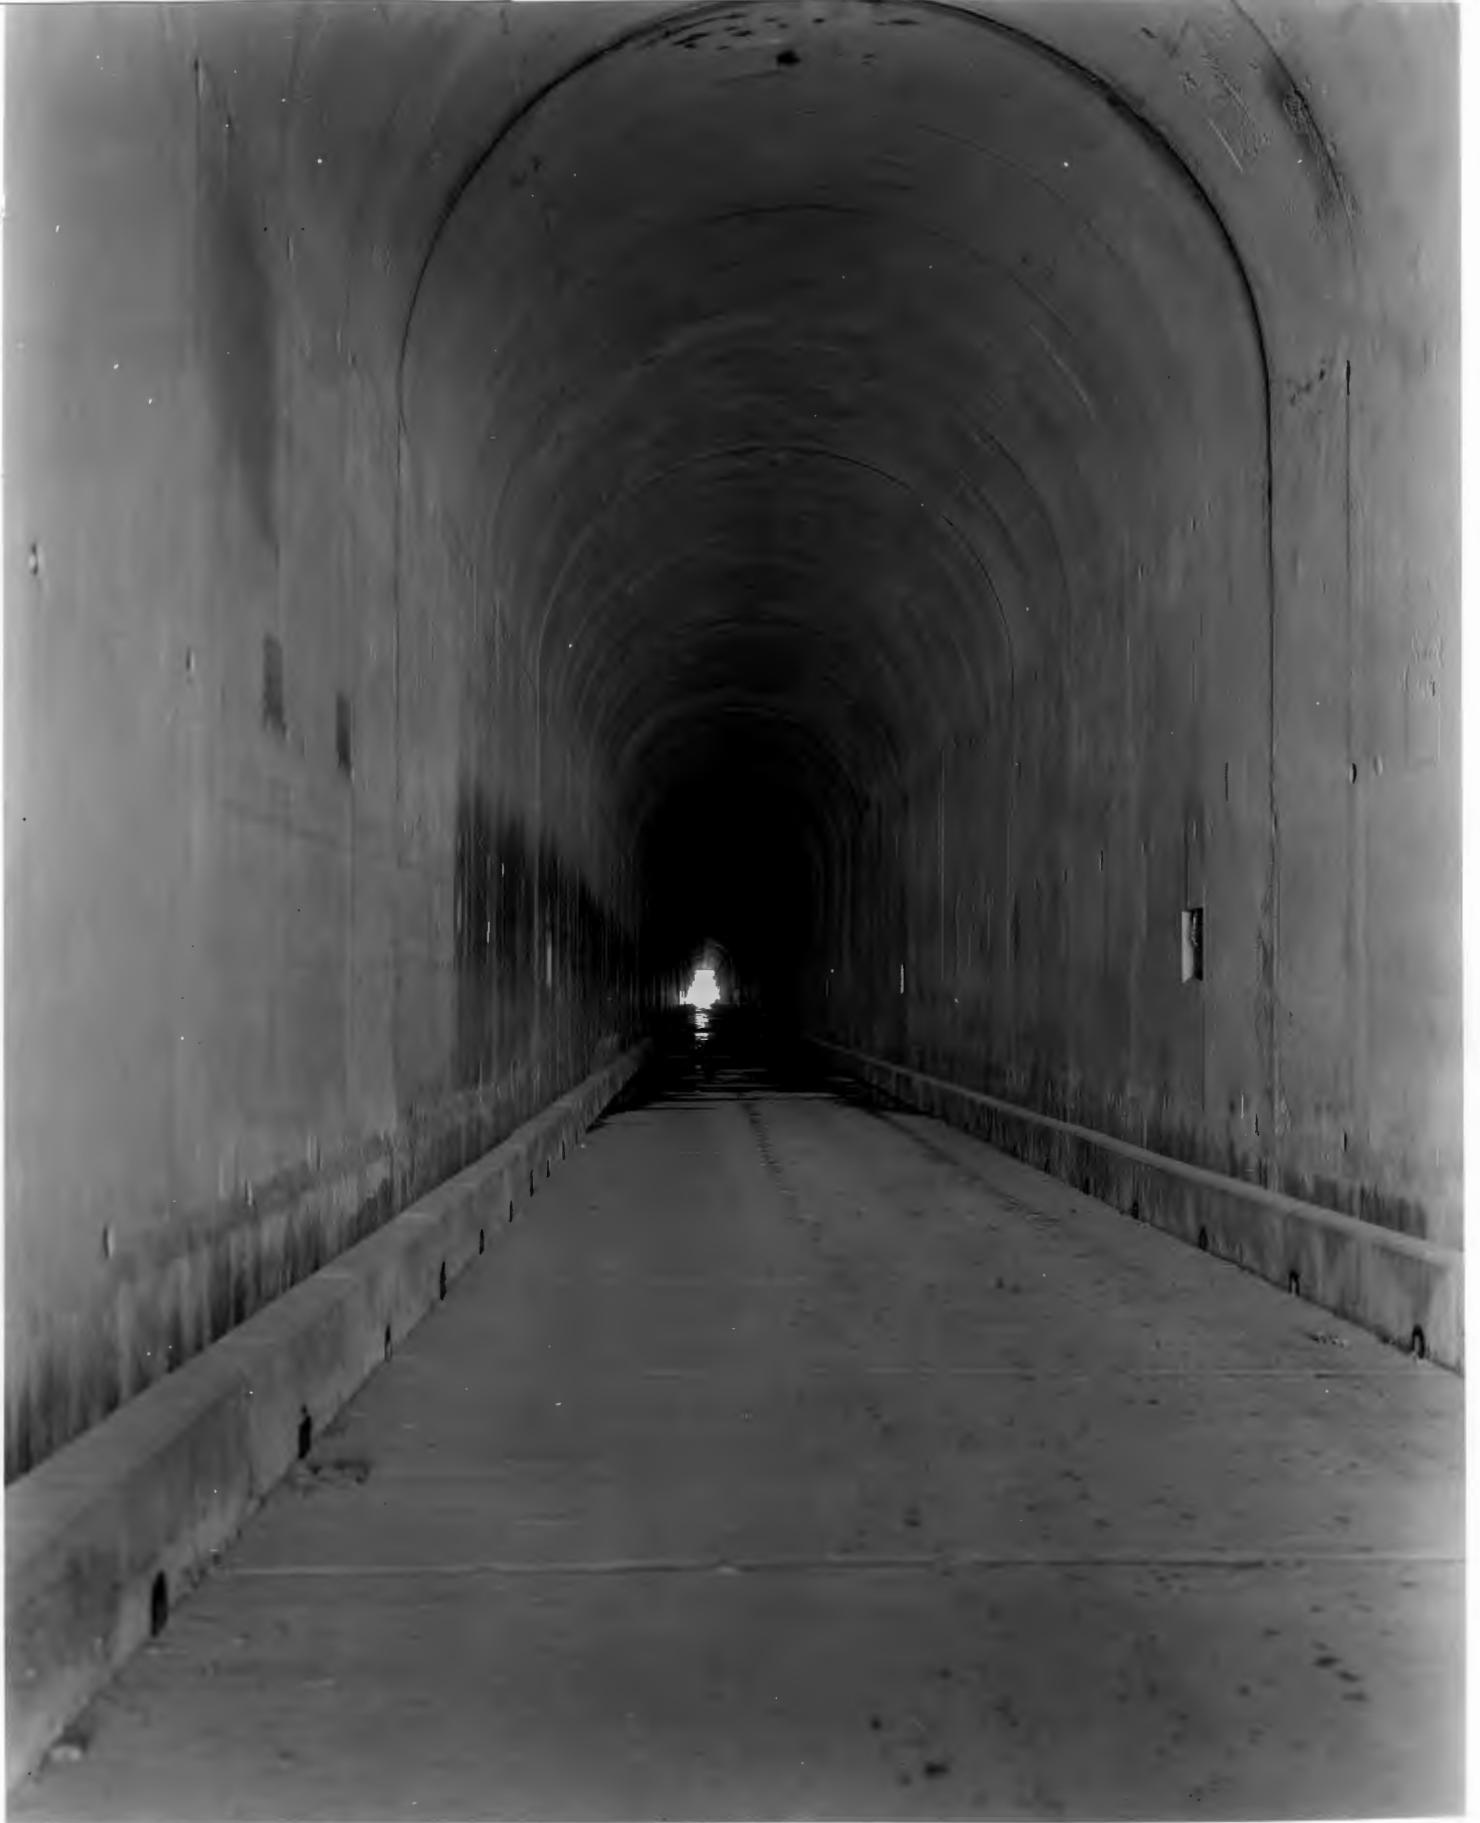
No. 857-1 12-5-60. Tunnels Nos. 4 and 5 (W.P.R.R. Nos. 7 and 8).  
Completed section of Tunnel No. 4. Portions of the invert are subject  
to standing water.

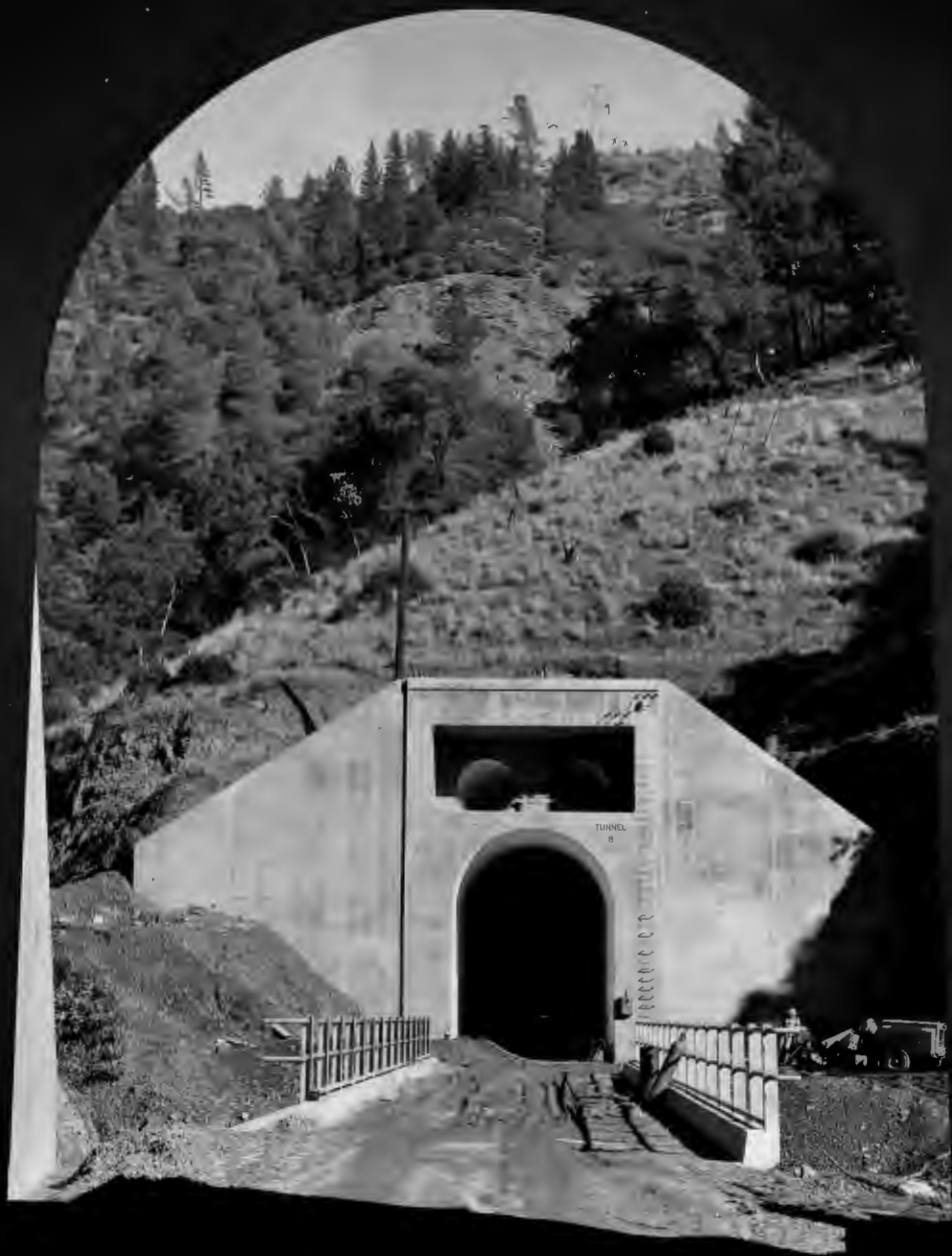
No. 857-2 12-5-60, Tunnels Nos. 4 and 5 (W.R.R.R. Nos. 7 and 8).  
Portal 5W from inside Tunnel No. 4. Ventilation chamber ready for  
fans. Dark Canyon Bridge completed.

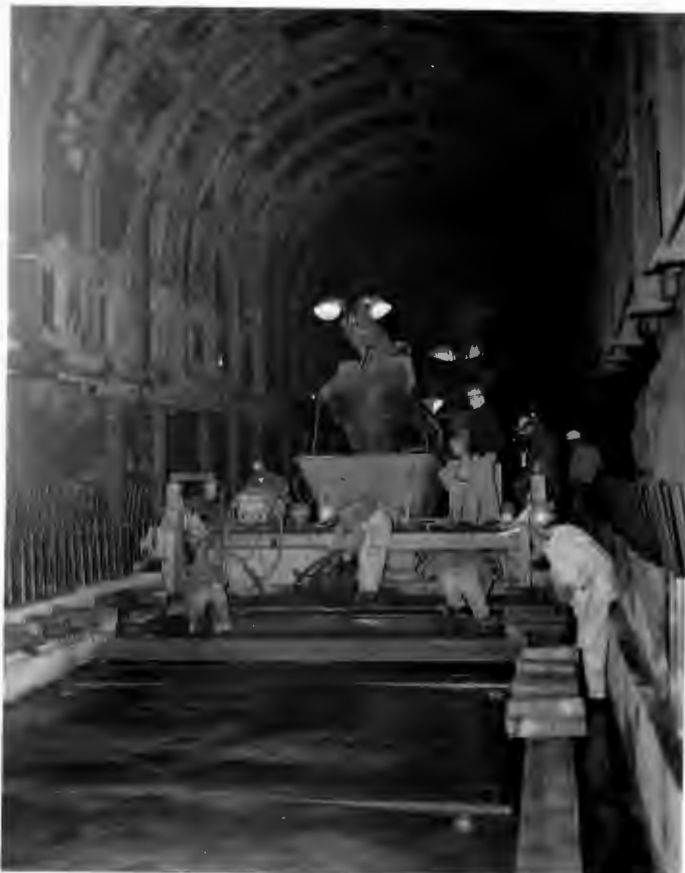
No. 894-5 2-3-61  
Tunnels Nos. 2 and 3 (W.P.R.R. 5 & 6)  
Tunnel No. 2. Invert paving train  
consisting of mixer, conveyor,  
hopper, spreader and vibrating  
screed operating in Tunnel No. 2.  
Note joint spacers and weep hole  
plugs.
