What the heck was POLING?

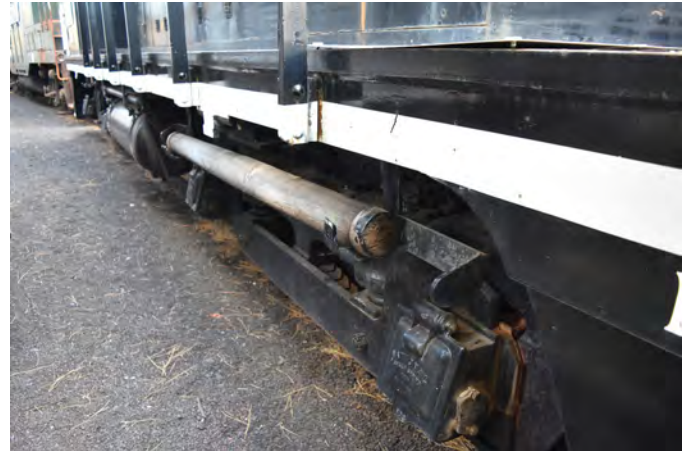
Top left: WP 6550, 1945 long gondola

Did you ever wonder what the small round dimples are that are found on many pieces of our equipment at the museum? They are what were known as pole pockets. A push pole was used to move equipment on adjacent tracks during switching. Pole pockets are found on a wide variety of equipment at the museum on both cars and locomotives from before the 1960's. Our Western Pacific 501, 1939 EMC SW-1, locomotive still carries a pole under the fireman's walkway.

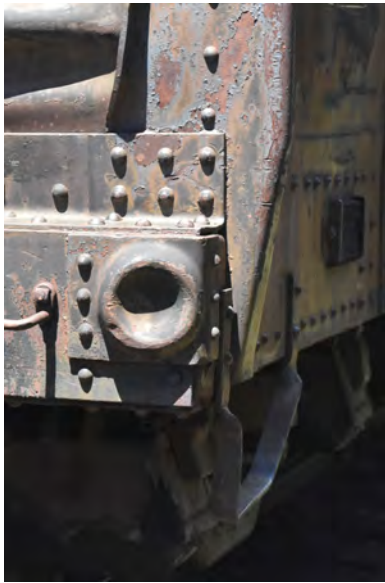
Top right: WP 501, 1939 EMC SW-1

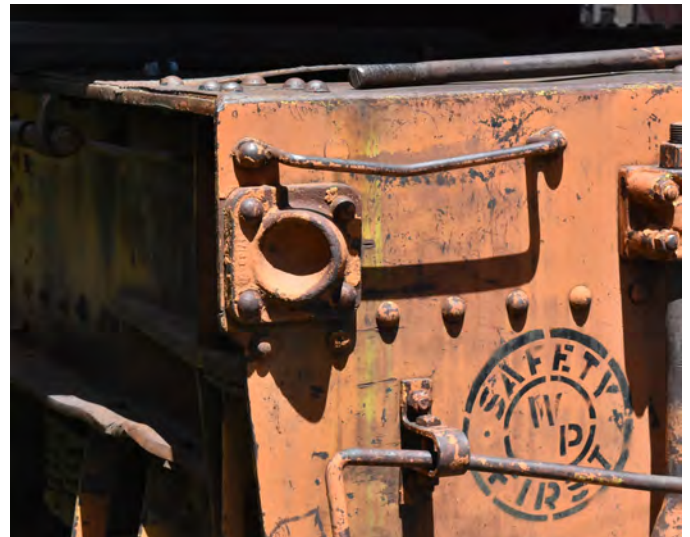
Above: WPMW 90, 1952 Brownhoist Crane

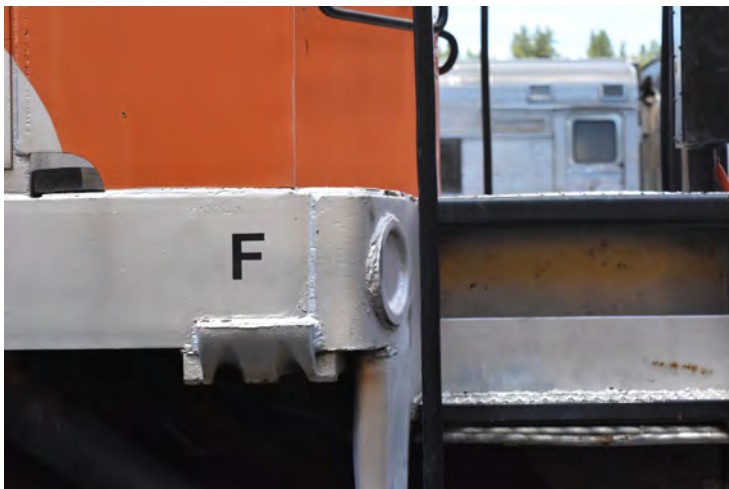
Bottom left: WP 707, 1952 EMD GP7
