Mechanical Department Report *DS ELEMS – Mechanic*

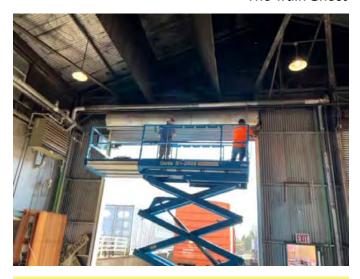
New roll up doors on east end of shop being installed on August 5, 2022.

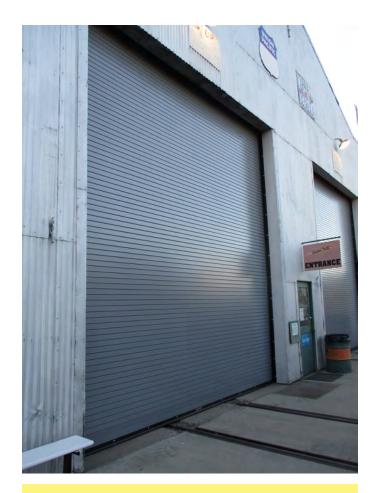
New Roll Up Doors on East End of Shop After many years of being out of service, the doors on the east end of the shop were replaced August 1-4, 2022.
