My First Locomotive Inspection

- Nicholas Manos

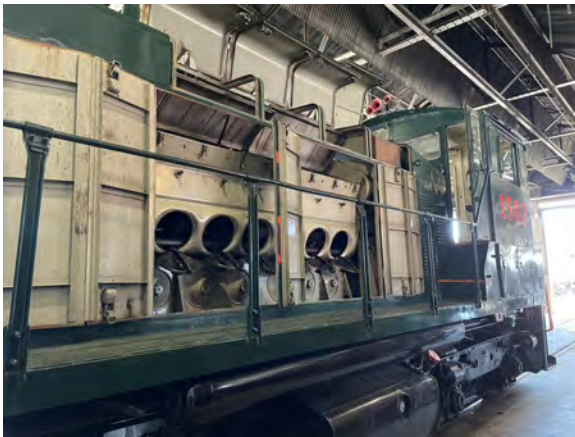
Lots of cleaning was on tap for the engine block, too. We used solvents and rags to clean the ex-

terior of the block, as well as the interior surfaces of the air box. On a two-stroke supercharged diesel engine, the air intake is not just charged for compression, the pressure is also used to clear out the combustion gasses from the power stroke. This process isn't completely smooth, so some of those combustion products end up flowing back into the air box and it makes for quite a mess.

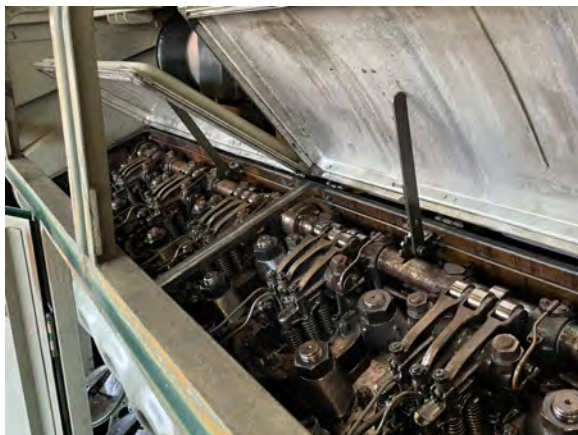
We then removed all the inspection covers in the engine block and opened up the top deck. Inspections were performed on camshaft lobes, rocker arms, valves, injectors, various bolt and nut torque, coolant pipes and connections, piston skirts, piston rings, connecting rods, oil passages, oil lines and various bearings. It was gearhead heaven, at least until it was time to replace all the covers and clean everything again.
