INVESTIGATION NO. 2456

THE WESTERN PACIFIC RAILROAD COMPANY

REPORT IN RE ACCIDENT

AT DEL PASO, CALIF., ON

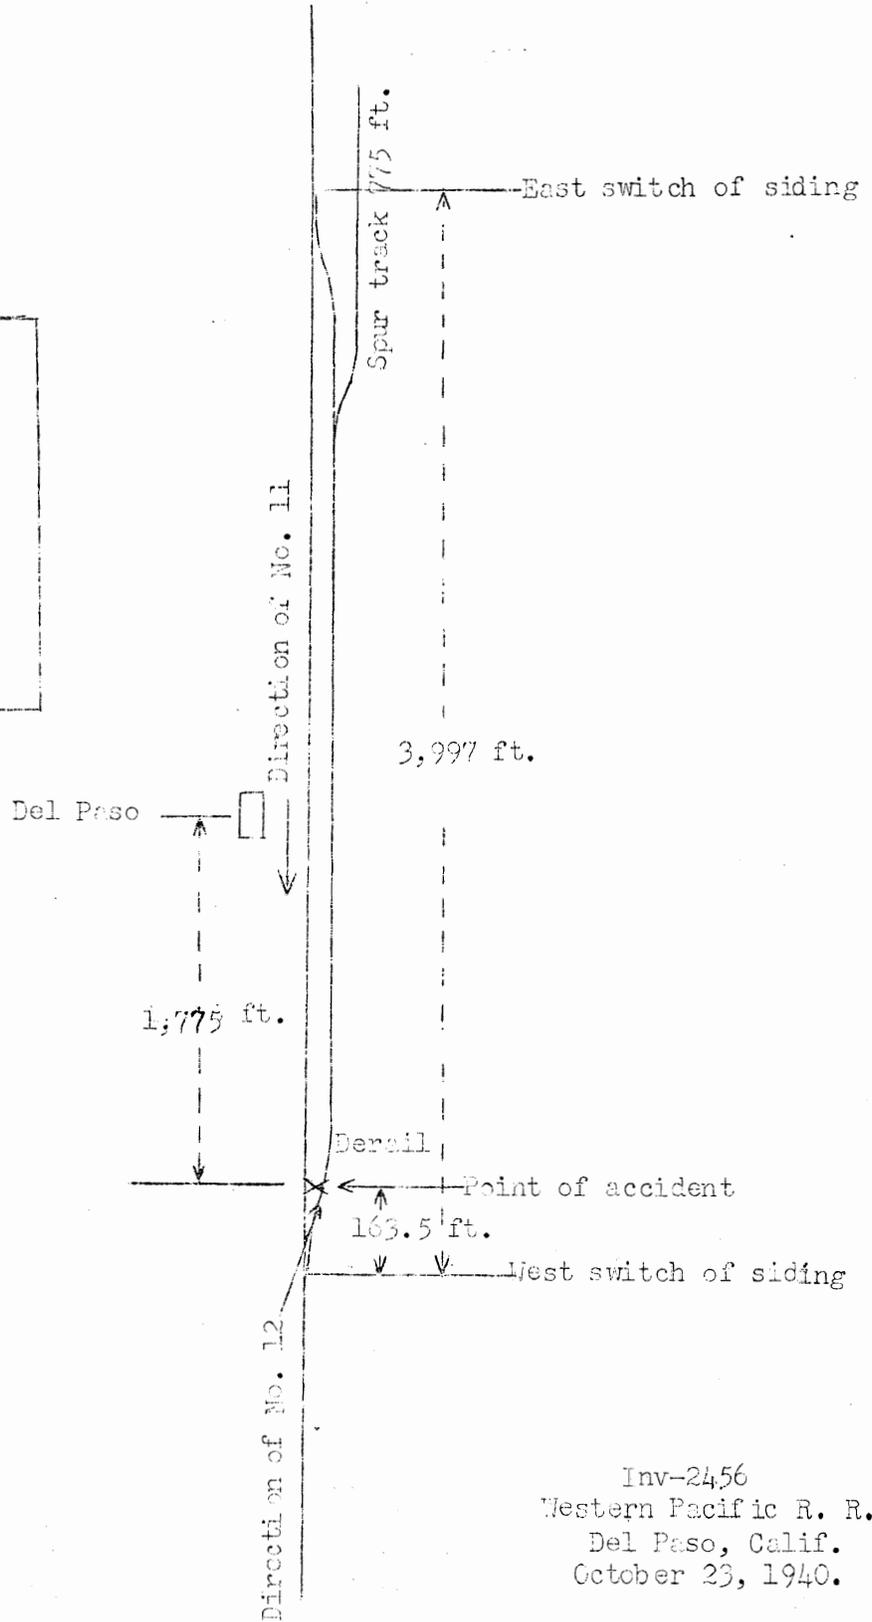
Inv-2456
 Western Pacific R. R.
 Del Paso, Calif.
 October 23, 1940.

- o Oroville, Calif.
26.3 mi.
- o Marysville
35 mi.
- o Del Paso
- X Point of accident
5.2 mi.
- o Sacramento
24.7 mi.
- o Thortnton
20.1 mi.
- o Stockton, Calif.
