INVESTIGATION NO. 2772  
THE WESTERN PACIFIC RAILROAD COMPANY  
REPORT IN RE ACCIDENT  
NEAR PULGA, CALIF., ON  
FEBRUARY 10, 1944

Accident near Pulga, Calif., on February 10, 1944, caused  
by failure to provide protection for the movement of  
a track motor-car and trailer.

Inv. No. 2772  
 Western Pacific Railroad  
 Pulga, Calif.  
 February 10, 1944

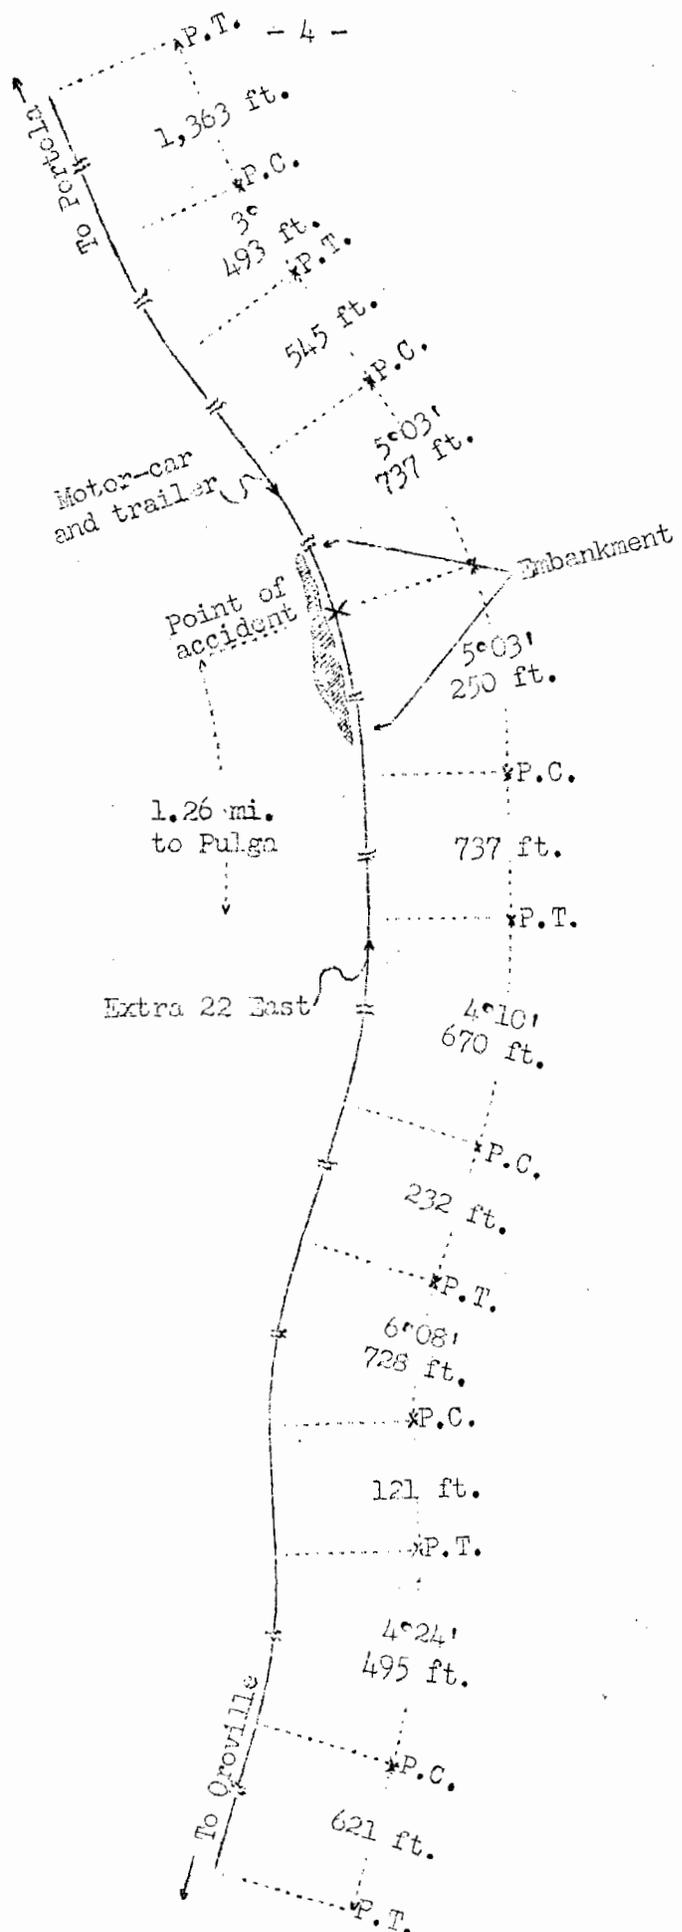
- o Fortola, Calif. 66.10 mi.
- o Camp Rodgers 14.84 mi.
- X Point of accident 1.26 mi.
- o Pulga 21.60 mi.
- o Bloomer 12.50 mi.
- o Oroville, Calif.

Location of Accident and Method of Operation
