Title: WP MK 13 Po	rtable Drawing # 14- Rev. 22c
Disposal Syste Status Retired. Awaii	em. Car Danisha 27 Day 7 far
Measurement Time Frame: July, 200	Deadline Aspen Rd
Measured & James Hall Drawn By:	iwell Drawn Turbo Cad ® 11.1
Scale: 1/10	1.2" = 1'

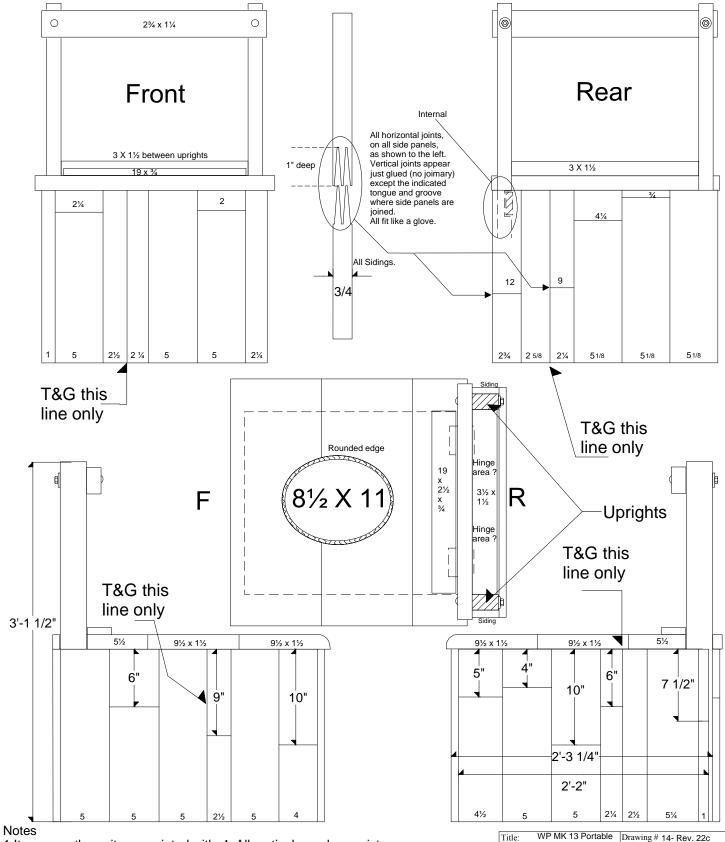
- 1 It appears the unit was painted with 4. All vertical panels consist "Red Lead" sometime in the past. of two sub panels that are
- 2 Believe the 3½ x 1½ between the uprights was a mounting plate for the hinges of a missing lid.
- 3 There is conjecture that this unit did have a lid and its missing.
- All vertical panels consist of two sub panels that are joined by Tongue & Groove. The subpanels are inturn assembled by joinary for any horiz. jiont and glue for all vertical joints.
