## OCTOBER TRACKWORK

- Wayne Monger, Assistant Roadmaster

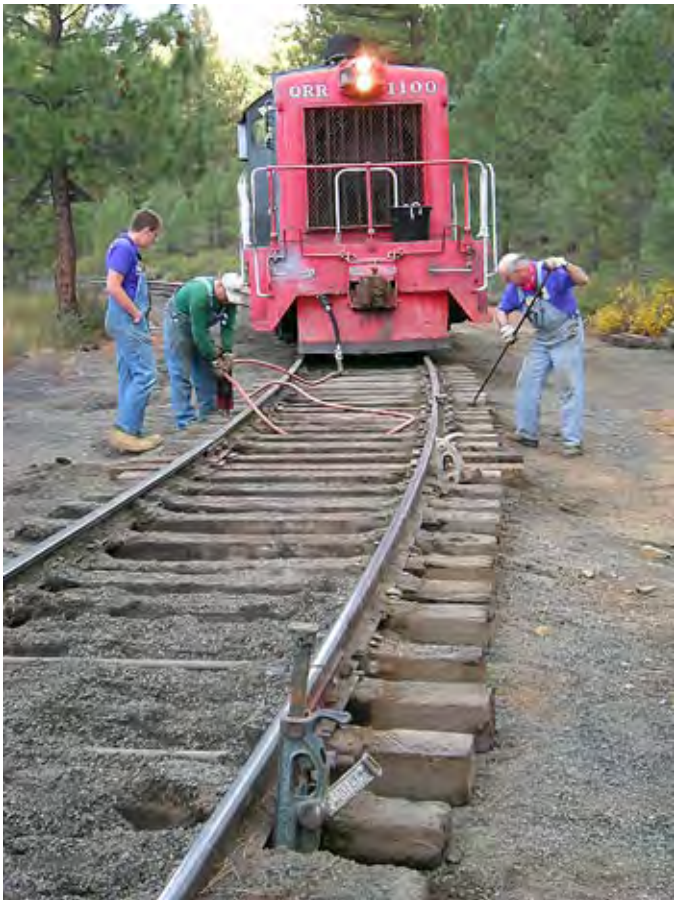
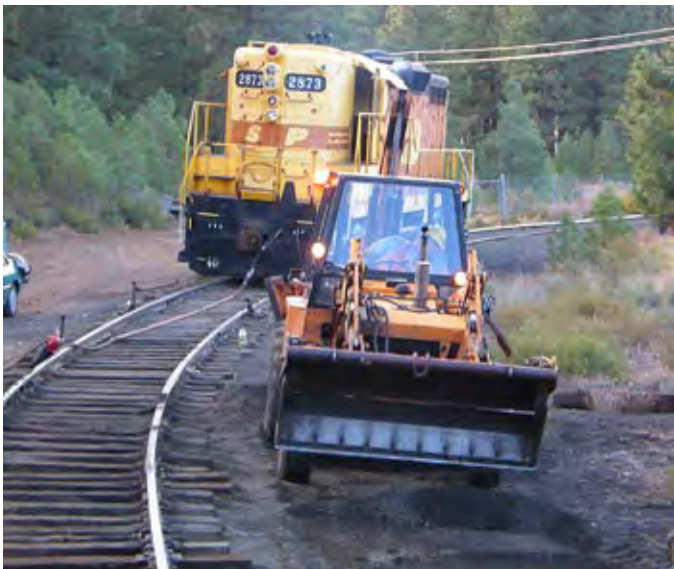
Some views from the Oct 24 - 25 track session. Our hardworking crews jack, align and reballast the balloon loop, aided by some of our locos and heavy machinery.  
-Wayne Monger photos
