Issue 170 - Spring 2016 Spring 2016 CMO Report

–Bil Jackson, CMO

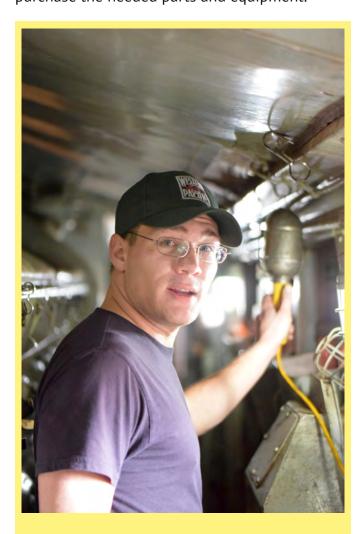
Fritz on the Job

Fritz is seen here preparing additional lighting in the body of WP F7 917D on 14 May 2016, to assist in the inspection of the prime mover. The 917 currently utilizes an EMD 16-567C prime mover, although it was originally equipped with the less maintenance-friendly 567B version of the engine.

Bil "1 L" Jackson and Fritz have been working steadily on the pre-season maintenance of the RAL locomotive fleet, having already finished SP2873 when this photo was taken. Since this photo was taken, 917 was successfully started, which you can watch on the museum website under the new photo and video gallery.

•Service the WP917D for this years duty.
