WP 165 May 2020 Work Session*- Roger Stabler, CMO Steam*

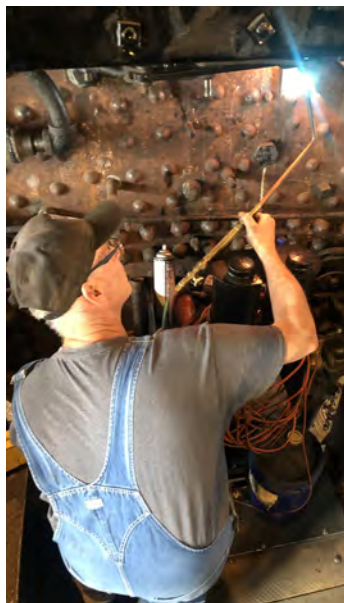
*Roger heating the throttle support to fit the new throttle lever
- photo by Mike Waters*

repacked the throttle gland. We then installed the new (to us) throttle lever donated by Steve Lee as the lever for the 165 was missing when we received the engine. It took a couple of hours to fit the new lever, but it is now in and the throttle is ready to go. We then turned our attention to the front footboard brackets and bolts that had previously been torched off. After a lot of heating and oiling, we were able to extract them without damaging the threads in the front pilot beam. New hardware has been ordered to fasten the footboards properly as they were done by the WP.
