Steam Work Session September 2019

A short work session was held September 27th-29th to continue work on the WP 165. Work was focused on mainly working on piping in the cab. Mike Waters lapped an injector valve seat after Roger Stabler cut new seats on the steam valve. We completed an injector and its piping. The firing valve was installed and the manifold body, made by Channing Walker, was installed.

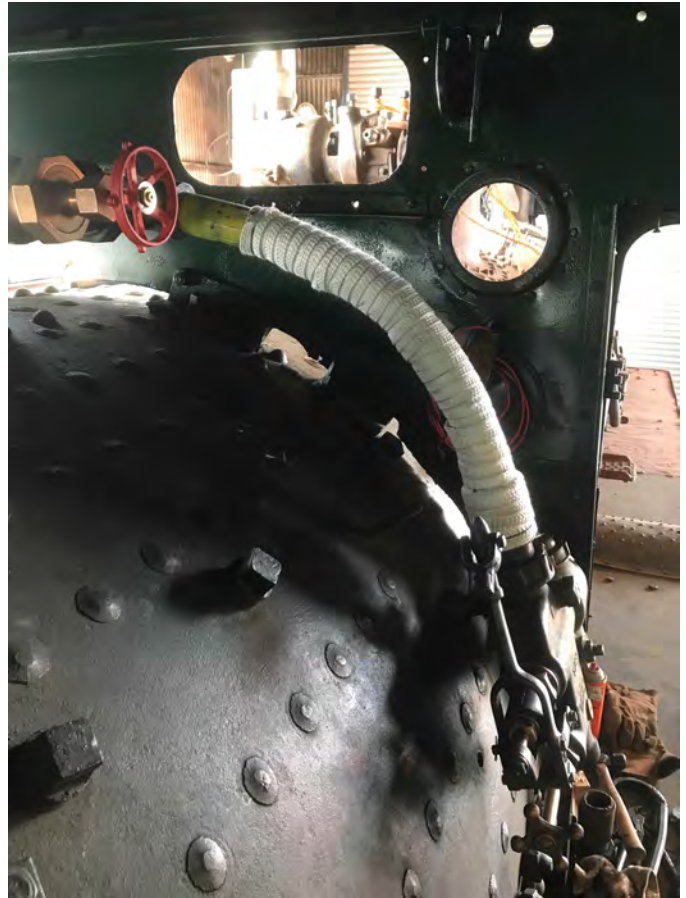
Firing valve quadrant installed by Channing Walker, Channing also made up a new fireman's manifold body.

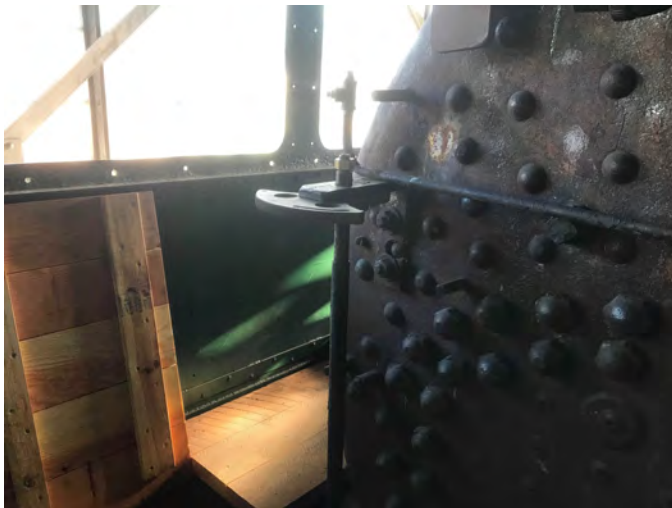
Steam Work Session September 2019, Completed engineer's injector

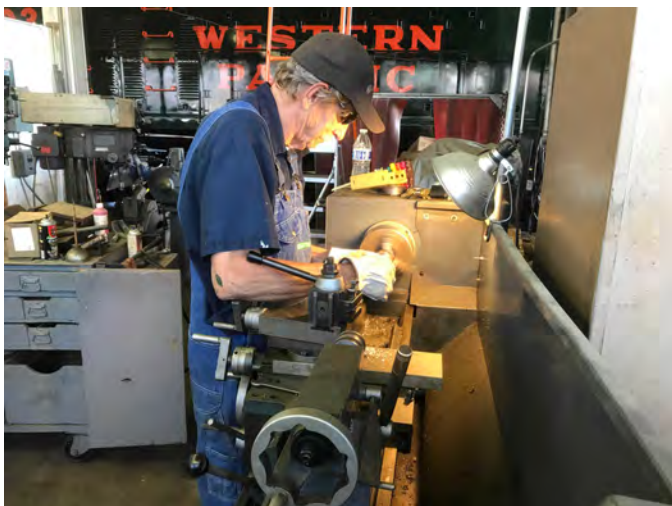
Mike Waters grinding valve for engineer's injector.
